# Uniform Mitigation Verification Inspection Form

| Inspection Date: <b>06-10-2025</b> | | |
| Owner Name: <b>Bermuda Greens Condominium Association</b> | | Contact Person: |
| Address: <b>13000 Castle Harbour Drive</b> | | Home Phone: |

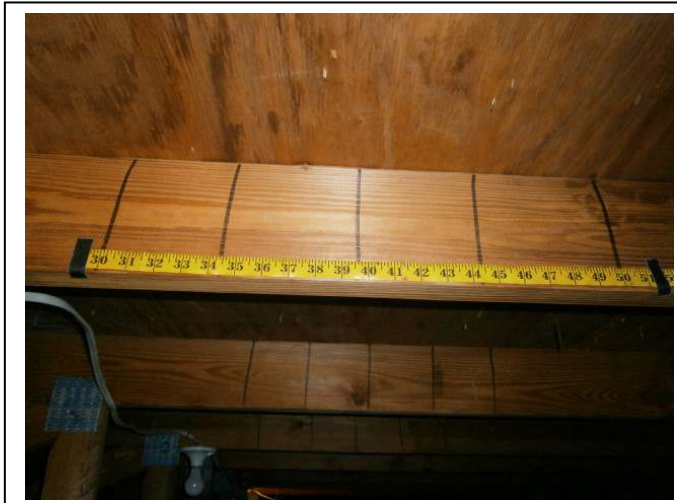
ROOF DECK ATTACHMENT – 8d nails within 6 inches along the edge

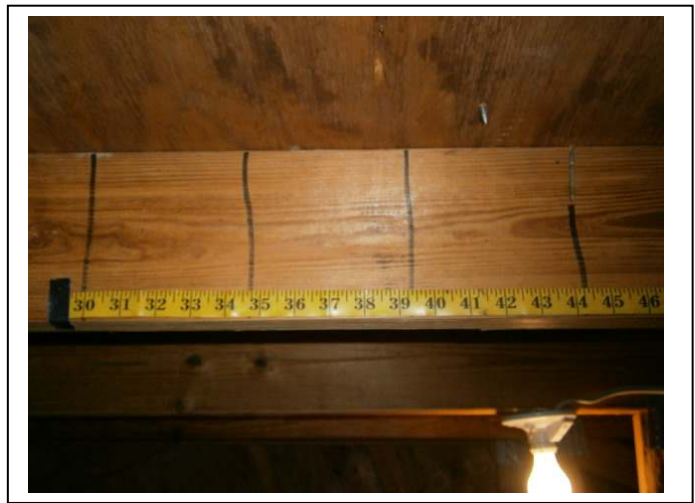
ROOF DECK ATTACHMENT – 8d nails within 6 inches in the field

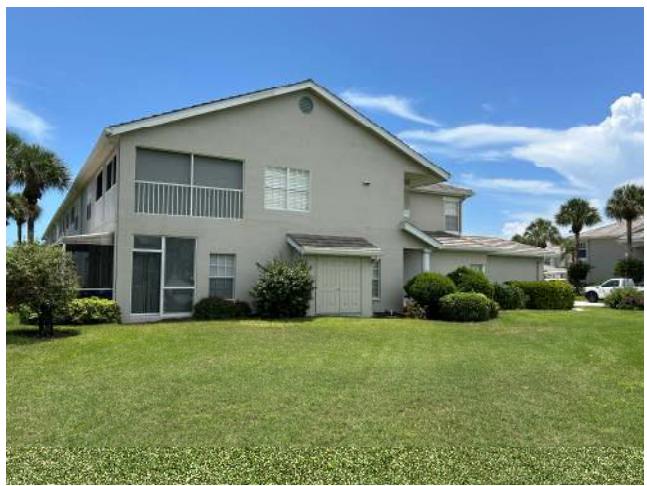
ROOF GEOMETRY – Gable / Other Roof Shape

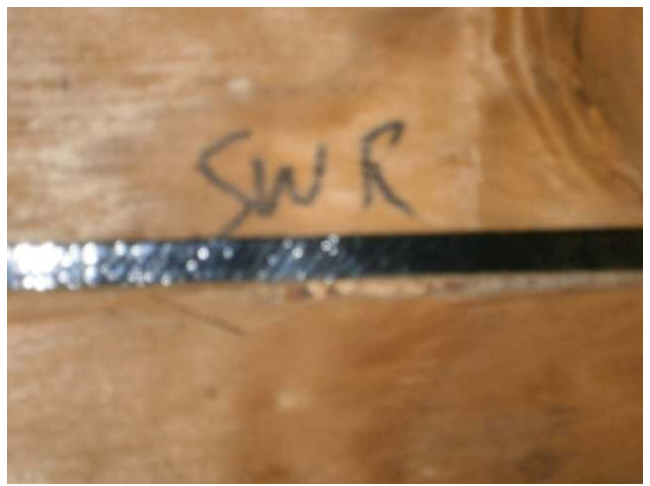
SECONDARY WATER BARRIER – A Peel &  
Stick adhesive polymer SWR Barrier was  
installed in 2014 when the covering system was  
replaced

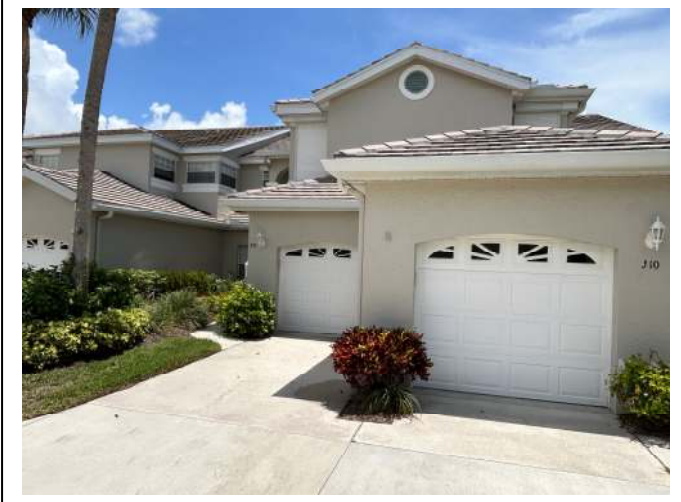
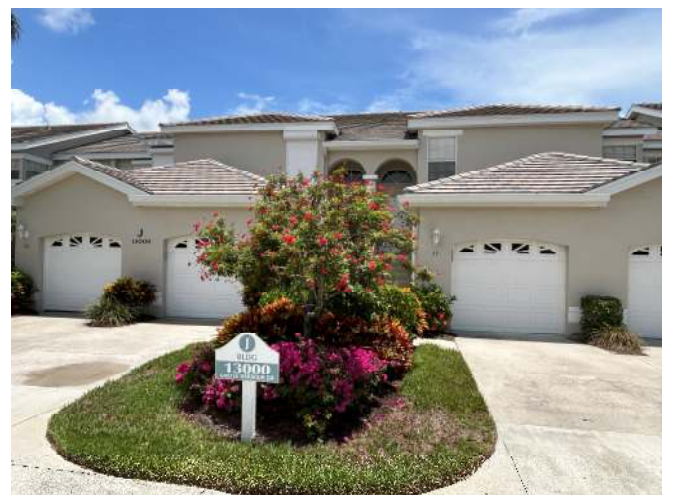
**OPENING PROTECTION** – Although some unit owners have installed wind-borne debris protection devices, others have not, leaving some of the openings (entry doors, glazed garage doors, window units & sliding doors) unprotected
