# Uniform Mitigation Verification Inspection Form

| Inspection Date: <b>06-10-2025</b> | | |
| Owner Name: <b>Bermuda Greens Condominium Association</b> | | Contact Person: |
| Address: <b>13020 Hamilton Harbour Drive</b> | | Home Phone: |

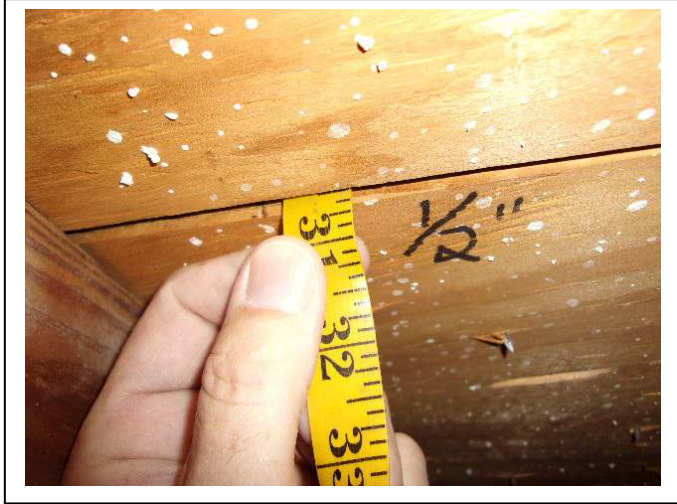
ROOF DECK THICKNESS – 15/32 to 1/2 inch  
plywood

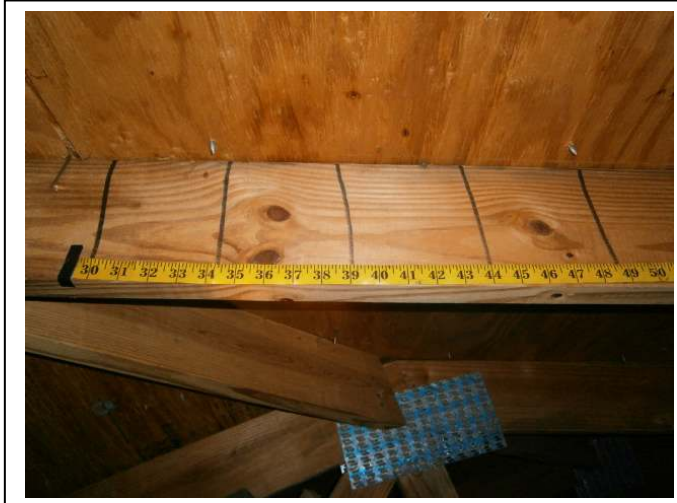
ROOF DECK ATTACHMENT – 8d nails within  
6 inches along the edge

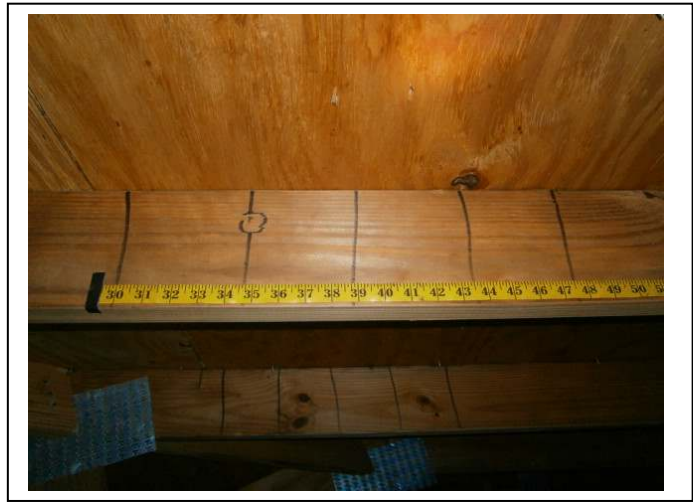
- ☒ C. Plywood/OSB roof sheathing with a minimum thickness of 7/16" inch attached to the roof truss/rafter (spaced a maximum of 24" inches o.c.) by 8d common nails spaced a maximum of 6" inches in the field. -OR- Dimensional lumber/Tongue & Groove decking with a minimum of 2 nails per board (or 1 nail per board if each board is equal to or less than 6 inches in width). -OR- Any system of screws, nails, adhesives, other deck fastening system or truss/rafter spacing that is shown to have an equivalent

ROOF DECK ATTACHMENT – 8d nails within  
6 inches in the field

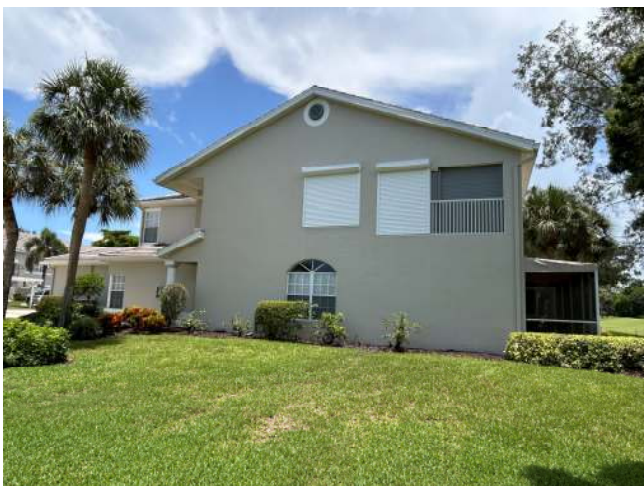
**ROOF GEOMETRY – Gable / Other Roof Shape**

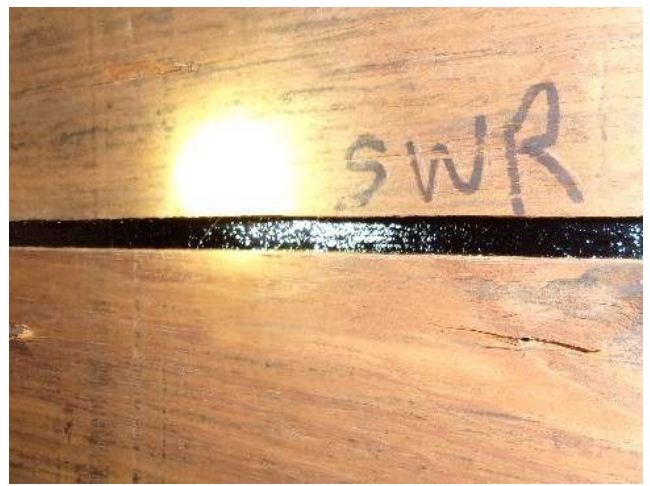
**SECONDARY WATER BARRIER – A Peel &  
Stick adhesive polymer SWR Barrier was  
installed in 2014 when the covering system was  
replaced**

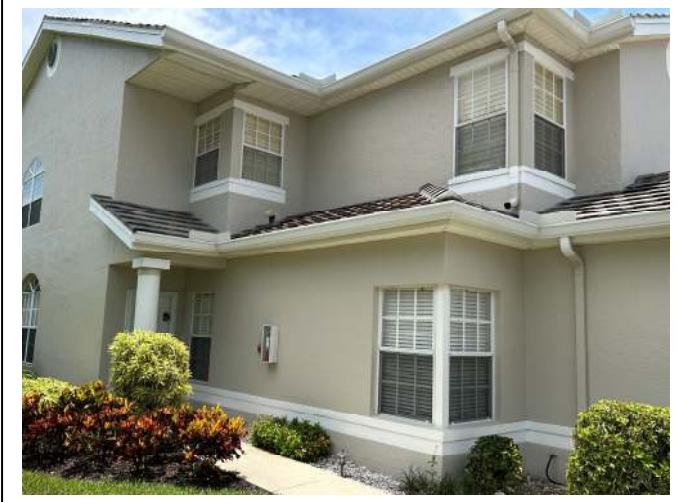
**OPENING PROTECTION** – Although some unit owners have installed wind-borne debris protection devices, others have not, leaving some of the openings (entry doors, glazed garage doors, window units & sliding doors) unprotected

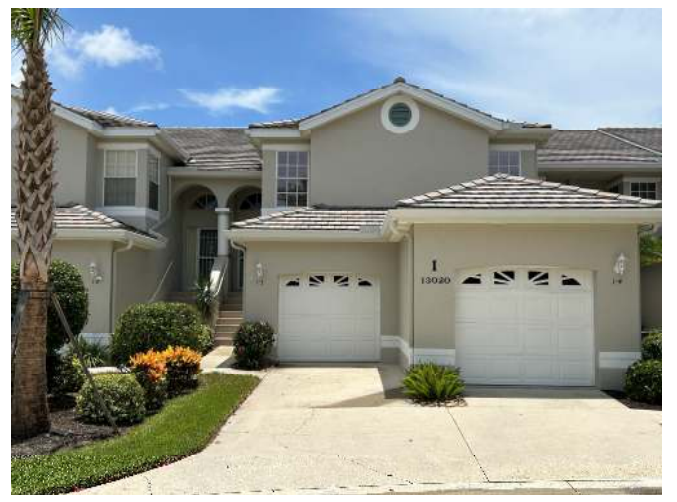
**OPENING PROTECTION** – Although some unit owners have installed wind-borne debris protection devices, others have not, leaving some of the openings (entry doors, glazed garage doors, window units & sliding doors) unprotected
