# Uniform Mitigation Verification Inspection Form

| Inspection Date: <b>06-10-2025</b> | | |
| Owner Name: <b>Bermuda Greens Condominium Association</b> | | Contact Person: |
| Address: <b>13060 Hamilton Harbour Drive</b> | | Home Phone: |

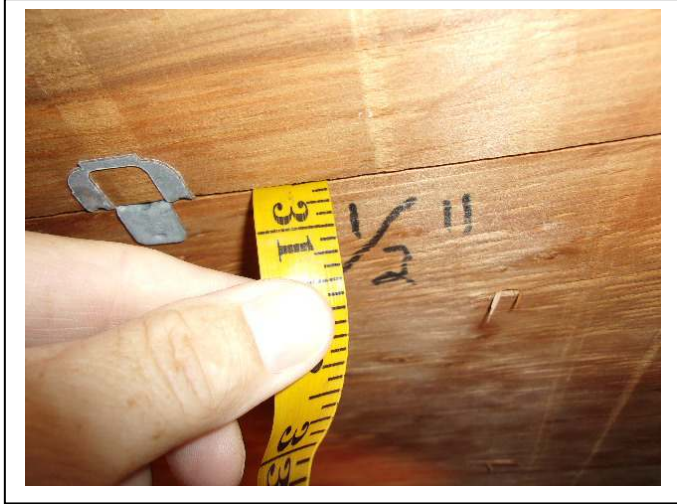
ROOF DECK THICKNESS – 15/32 to 1/2 inch  
plywood

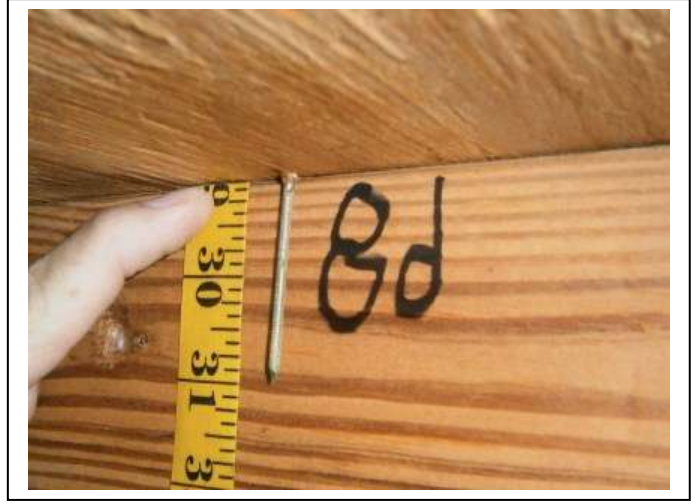
ROOF DECK ATTACHMENT – 8d ring shank  
nails added in 2014

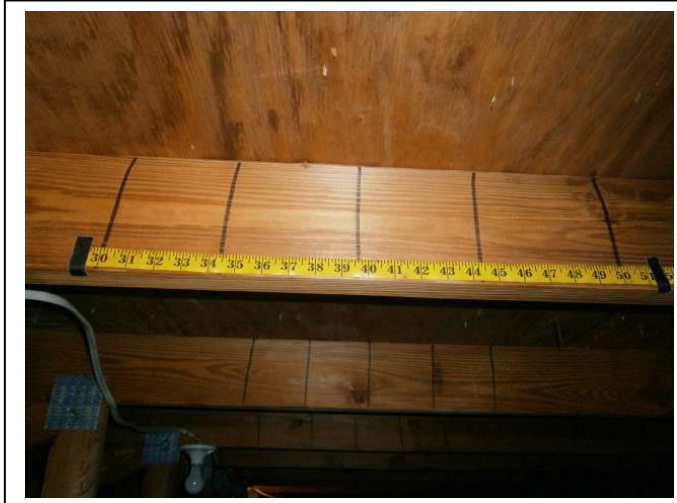
ROOF DECK ATTACHMENT – 8d nails within  
6 inches along the edge

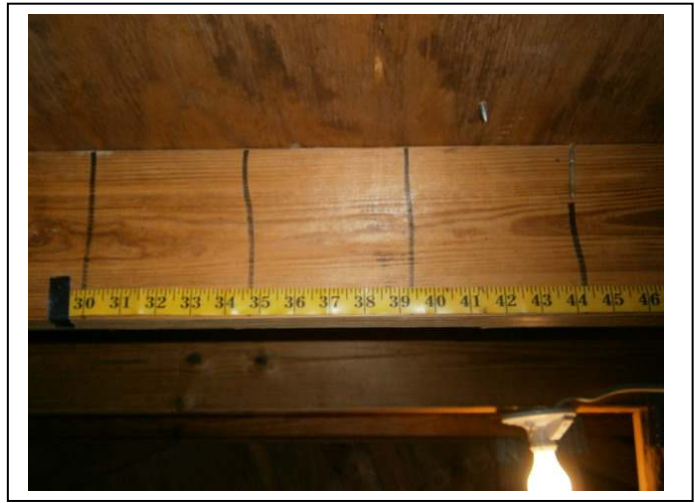
- ☒ C. Plywood/OSB roof sheathing with a minimum thickness of 7/16" inch attached to the roof truss/rafter (spaced a maximum of 24" inches o.c.) by 8d common nails spaced a maximum of 6" inches in the field. -OR- Dimensional lumber/Tongue & Groove decking with a minimum of 2 nails per board (or 1 nail per board if each board is equal to or less than 6 inches in width). -OR- Any system of screws, nails, adhesives, other deck fastening system or truss/rafter spacing that is shown to have an equivalent

ROOF DECK ATTACHMENT – 8d nails within  
6 inches in the field

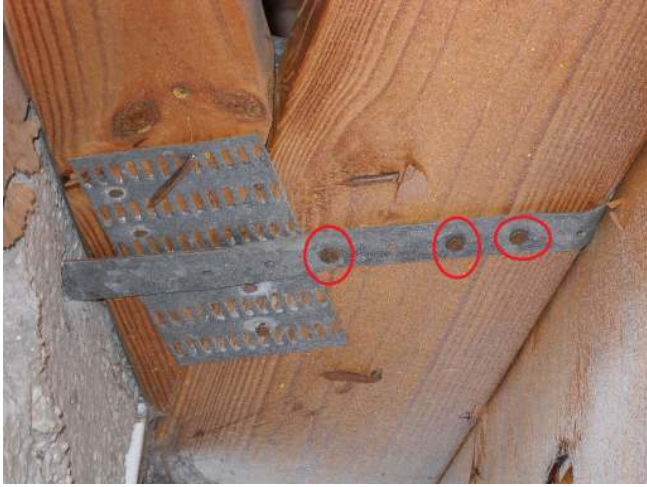
ROOF TO WALL ATTACHMENT – Properly  
installed Single Wraps

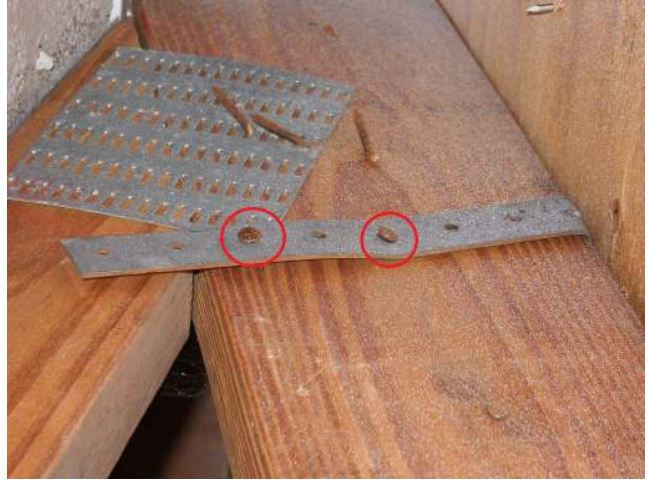
- ☒ C. Single Wraps
  - Metal connectors consisting of a single strap that wraps over the top of the truss/rafter and is secured with a minimum of 2 nails on the front side and a minimum of 1 nail on the opposing side.

ROOF TO WALL ATTACHMENT – Properly  
installed Single Wraps

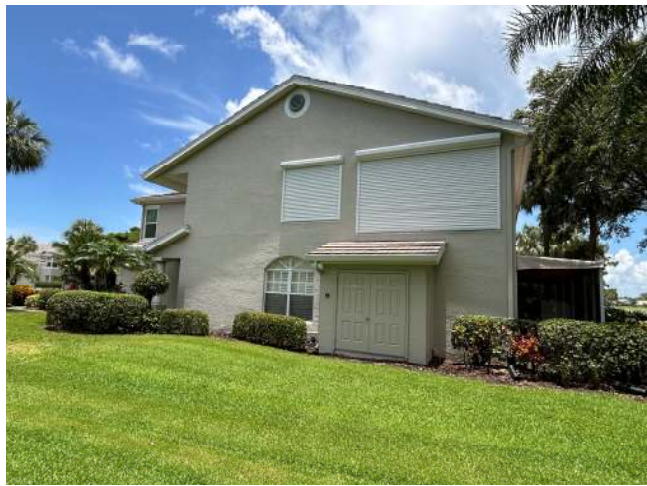
ROOF GEOMETRY – Gable / Other Roof Shape

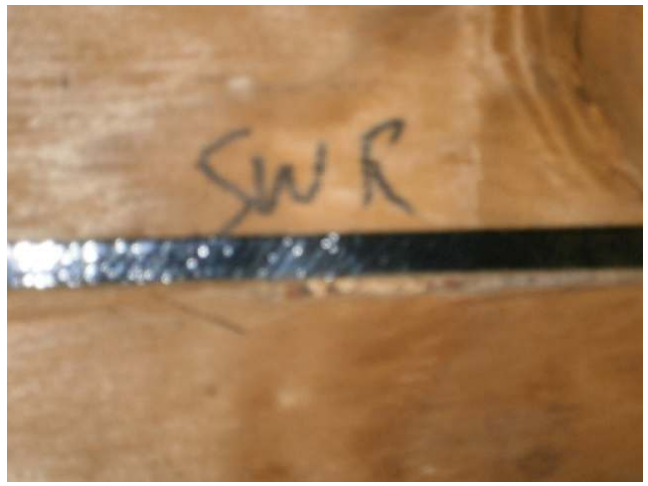
SECONDARY WATER BARRIER – A Peel &  
Stick adhesive polymer SWR Barrier was  
installed in 2014 when the covering system was  
replaced

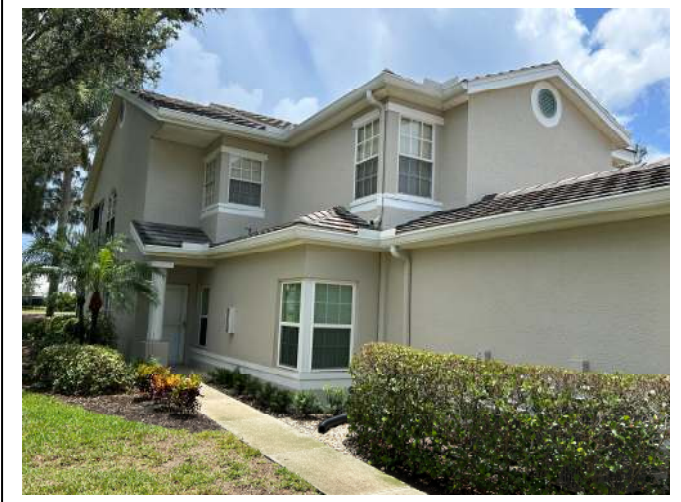
**OPENING PROTECTION** – Although some unit owners have installed wind-borne debris protection devices, others have not, leaving some of the openings (entry doors, glazed garage doors, window units & sliding doors) unprotected

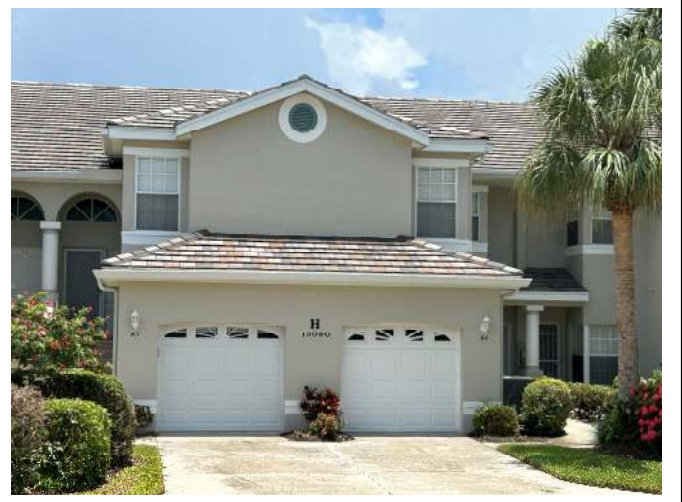
**OPENING PROTECTION** – Although some unit owners have installed wind-borne debris protection devices, others have not, leaving some of the openings (entry doors, glazed garage doors, window units & sliding doors) unprotected
