# Uniform Mitigation Verification Inspection Form

| Inspection Date: <b>06-10-2025</b> | | |
| Owner Name: <b>Bermuda Greens Condominium Association</b> | | Contact Person: |
| Address: <b>13080 Castle Harbour Drive</b> | | Home Phone: |

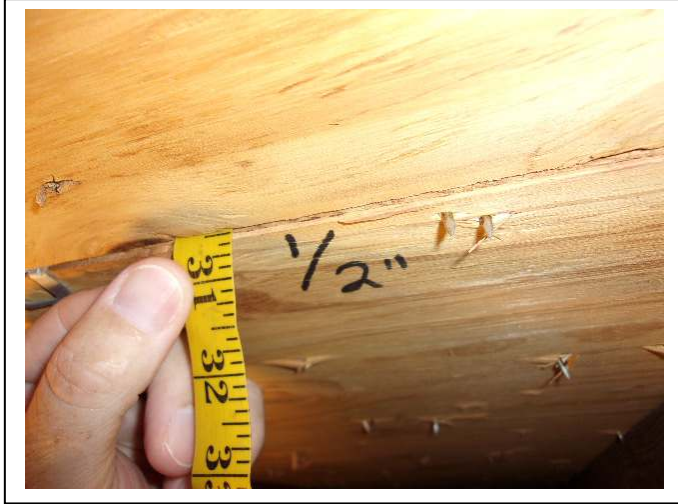
ROOF DECK THICKNESS – 15/32 to 1/2 inch plywood

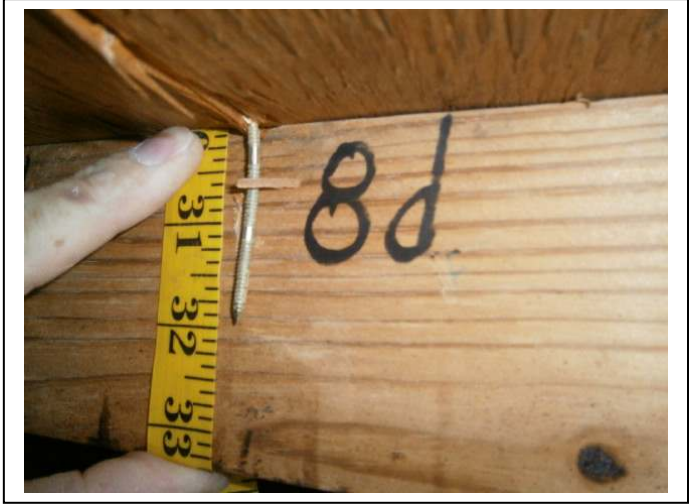
ROOF DECK ATTACHMENT – 8d ring shank nails added in 2014

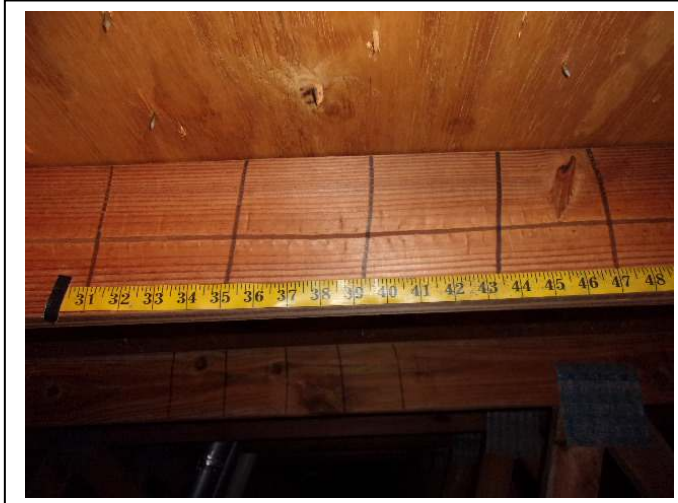
- ☒ C. Plywood/OSB roof sheathing with a minimum thickness of 7/16" inch attached to the roof truss/rafter (spaced a maximum of 24" inches o.c.) by 8d common nails spaced a maximum of 6" inches in the field. -OR- Dimensional lumber/Tongue & Groove decking with a minimum of 2 nails per board (or 1 nail per board if each board is equal to or less than 6 inches in width). -OR- Any system of screws, nails, adhesives, other deck fastening system or truss/rafter spacing that is shown to have an equivalent

ROOF DECK ATTACHMENT – 8d nails within 6 inches along the edge

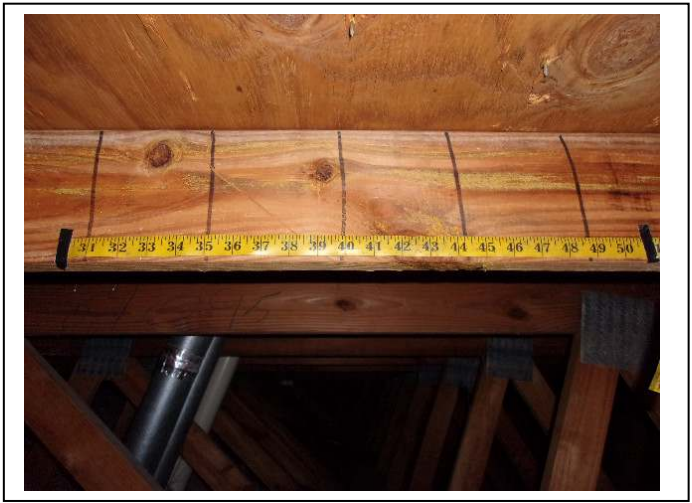
ROOF DECK ATTACHMENT – 8d nails within 6 inches in the field

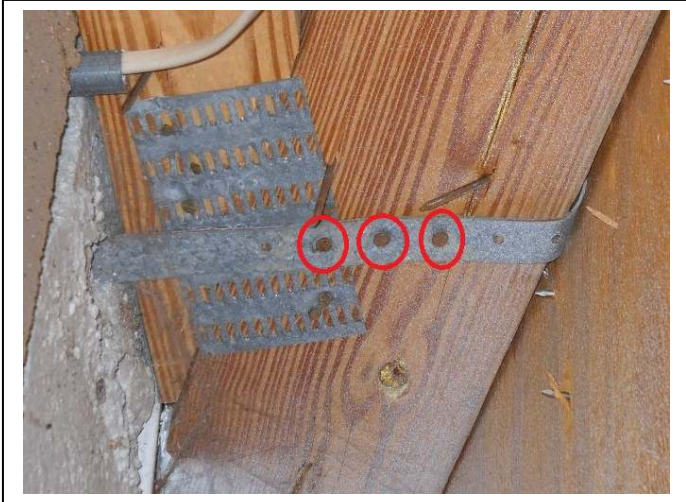
- ☒ C. Single Wraps
  - Metal connectors consisting of a single strap that wraps over the top of the truss/rafter and is secured with a minimum of 2 nails on the front side and a minimum of 1 nail on the opposing side.

ROOF TO WALL ATTACHMENT – Properly installed Single Wraps

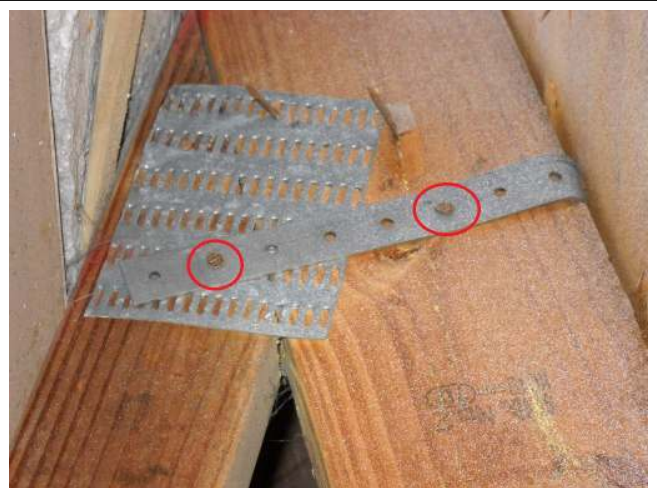
ROOF TO WALL ATTACHMENT – Properly installed Single Wraps

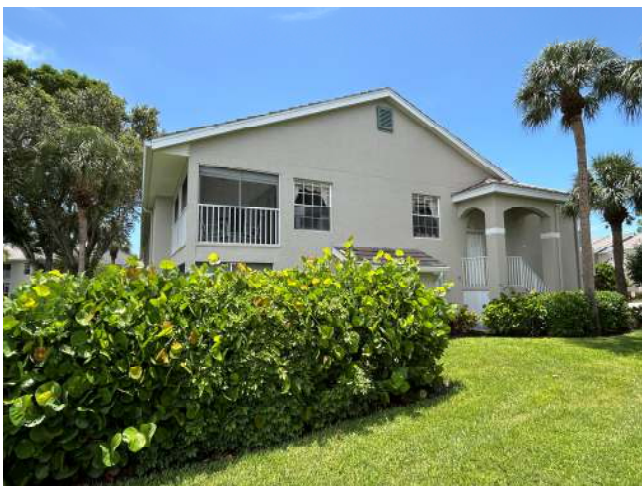
ROOF GEOMETRY – Gable / Other Roof Shape

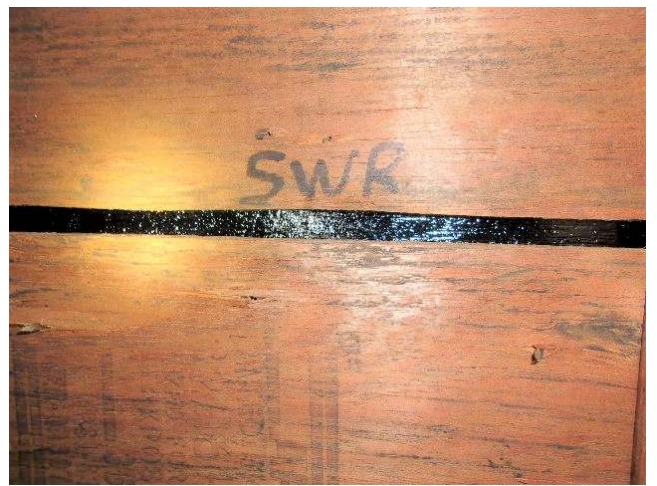
- ☒ A. SWR (also called Sealed Roof Deck) Self-adhering polymer modified-bitumen roofing underlayment applied directly to the sheathing or foam adhesive SWR barrier (not foamed-on insulation) applied as a supplemental means to protect the dwelling from water intrusion in the event of roof covering loss.
- ☐ B. No SWR.
- ☐ C. Unknown or undetermined.

SECONDARY WATER BARRIER – A Peel & Stick adhesive polymer SWR Barrier was installed in 2014 when the covering system was replaced

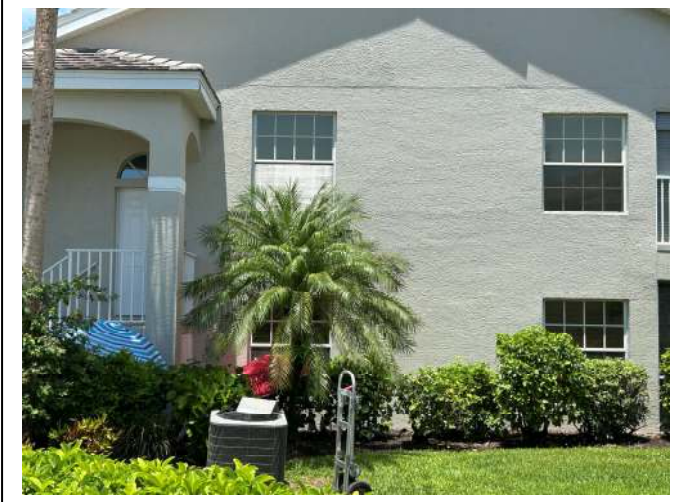
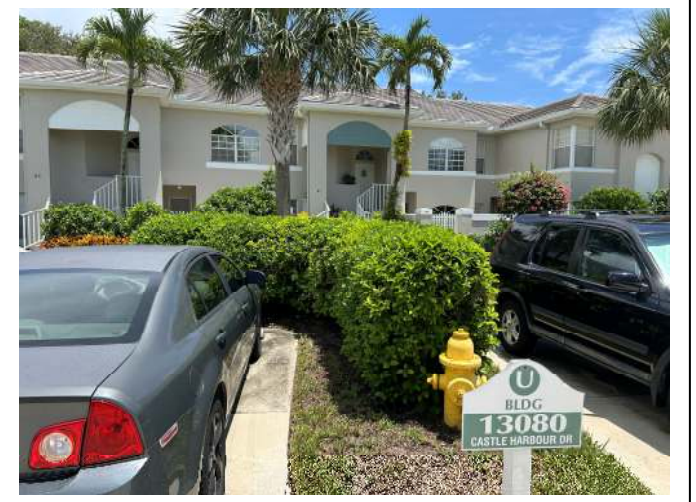
| Opening Protection Level Chart<br>Place an "X" in each row to identify all forms of protection in use for each opening type. Check only one answer below (A thru X), based on the weakest form of protection (lowest row) for any of the Glazed openings and indicate the weakest form of protection (lowest row) for Non-Glazed openings. | | Glazed Openings | | | | Non-Glazed Openings | |
|---|---|---|---|---|---|---|---|
| X | No Windborne Debris Protection | X | | | | X | |

OPENING PROTECTION – Although some unit owners have installed wind-borne debris protection devices, others have not, leaving some of the openings (entry doors, window units & sliding doors) unprotected
