# Uniform Mitigation Verification Inspection Form

| Inspection Date: <b>06-10-2025</b> | | |
| Owner Name: <b>Bermuda Greens Condominium Association</b> | | Contact Person: |
| Address: <b>13093 Castle Harbour Drive</b> | | Home Phone: |

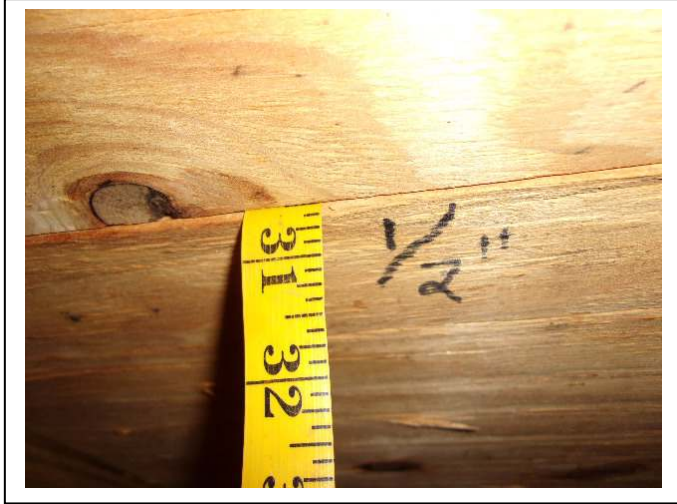
ROOF DECK THICKNESS – 15/32 to 1/2 inch plywood

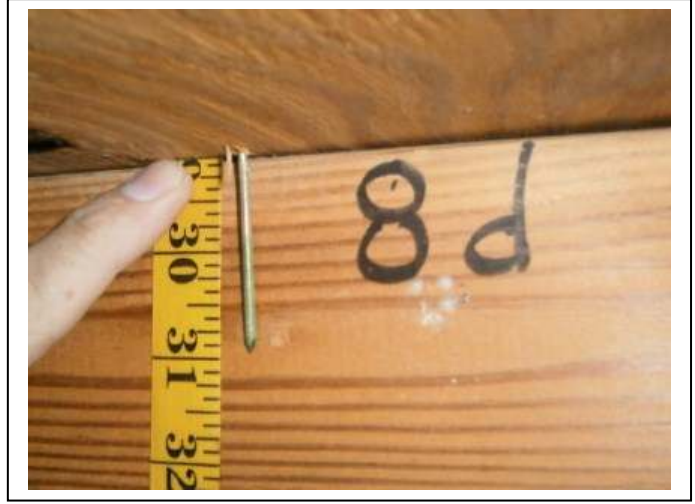
ROOF DECK ATTACHMENT – 8d ring shank nails added in 2014

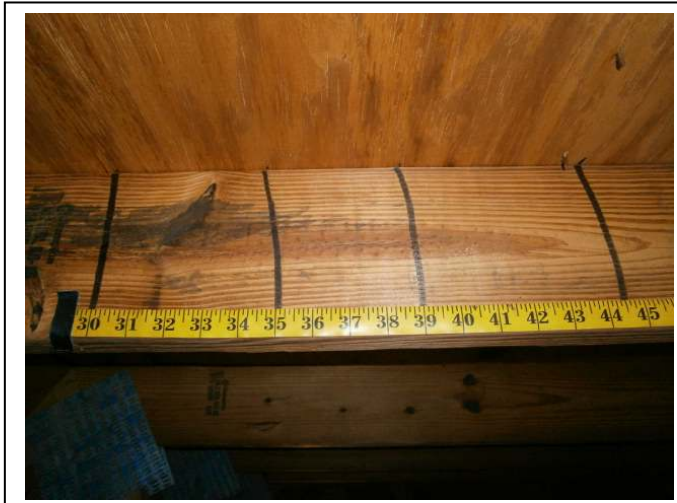
ROOF DECK ATTACHMENT – 8d nails within 6 inches along the edge

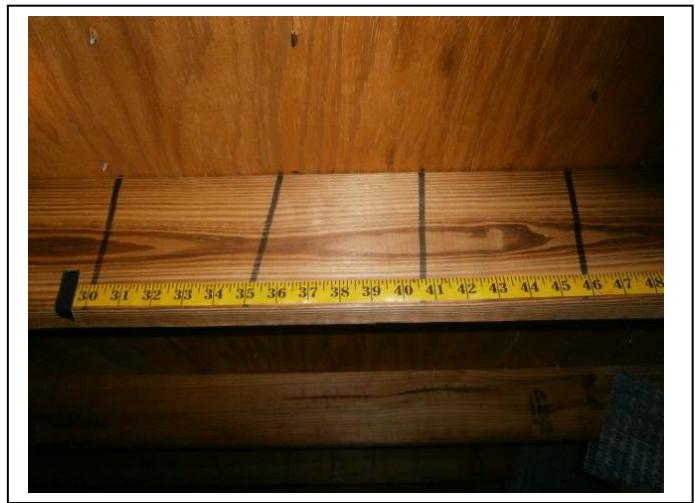
- ☒ C. Plywood/OSB roof sheathing with a minimum thickness of 7/16" inch attached to the roof truss/rafter (spaced a maximum of 24" inches o.c.) by 8d common nails spaced a maximum of 6" inches in the field. -OR- Dimensional lumber/Tongue & Groove decking with a minimum of 2 nails per board (or 1 nail per board if each board is equal to or less than 6 inches in width). -OR- Any system of screws, nails, adhesives, other deck fastening system or truss/rafter spacing that is shown to have an equivalent

ROOF DECK ATTACHMENT – 8d nails within 6 inches in the field

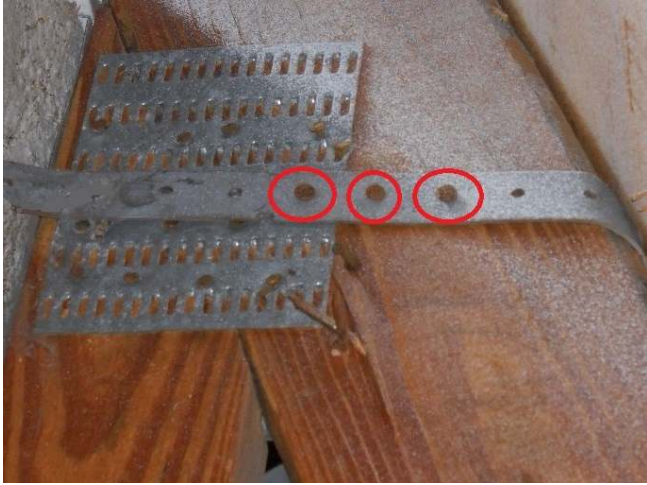
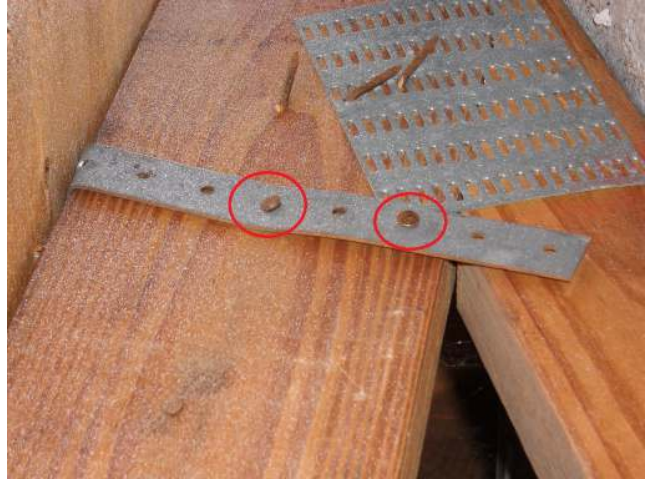
- ☒ C. Single Wraps
  - Metal connectors consisting of a single strap that wraps over the top of the truss/rafter and is secured with a minimum of 2 nails on the front side and a minimum of 1 nail on the opposing side.

ROOF TO WALL ATTACHMENT – Properly installed Single Wraps

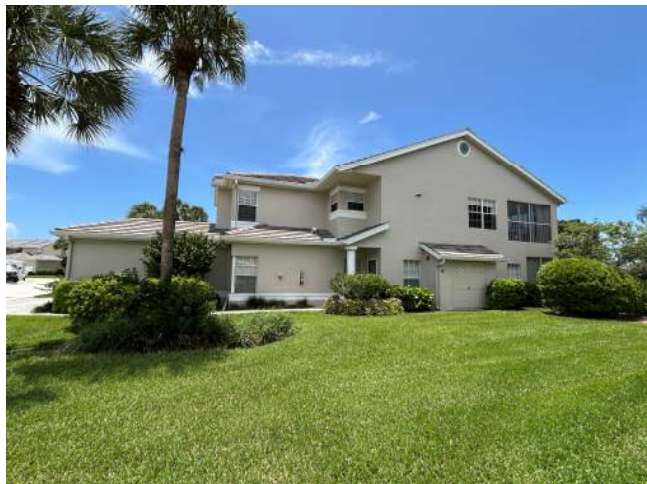
ROOF GEOMETRY – Gable / Other Roof Shape

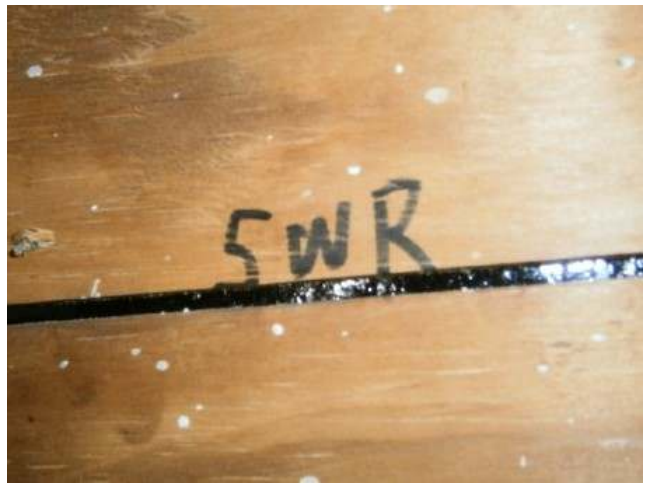
- ☒ A. SWR (also called Sealed Roof Deck) Self-adhering polymer modified-bitumen roofing underlayment applied directly to the sheathing or foam adhesive SWR barrier (not foamed-on insulation) applied as a supplemental means to protect the dwelling from water intrusion in the event of roof covering loss.
- ☐ B. No SWR.
- ☐ C. Unknown or undetermined.

SECONDARY WATER BARRIER – A Peel & Stick adhesive polymer SWR Barrier was installed in 2014 when the covering system was replaced

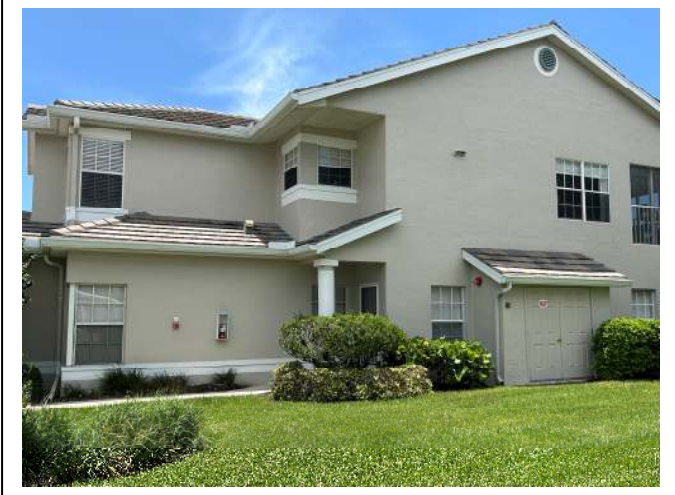
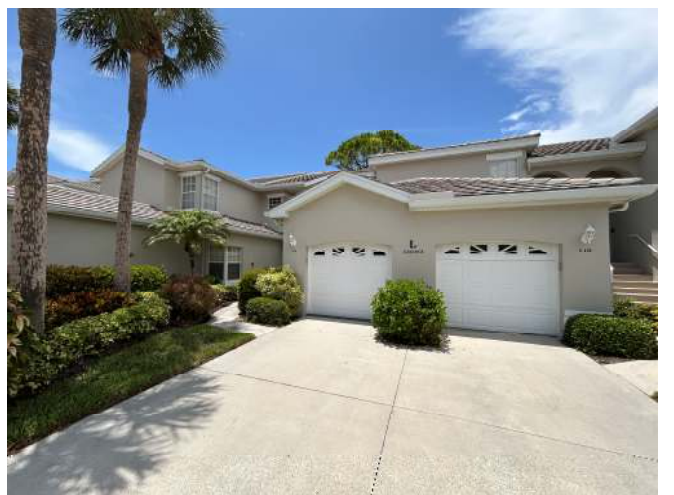
| Opening Protection Level Chart<br>Place an "X" in each row to identify all forms of protection in use for each opening type. Check only one answer below (A thru X), based on the weakest form of protection (lowest row) for any of the Glazed openings and indicate the weakest form of protection (lowest row) for Non-Glazed openings. | | Glazed Openings | | | | Non-Glazed Openings | |
|---|---|---|---|---|---|---|---|
| X | No Windborne Debris Protection | X | X | | | X | |

**OPENING PROTECTION** – Although some unit owners have installed wind-borne debris protection devices, others have not, leaving some of the openings (entry doors, glazed garage doors, window units & sliding doors) unprotected
