# Uniform Mitigation Verification Inspection Form

| Inspection Date: <b>06-10-2025</b> | | |
| Owner Name: <b>Bermuda Greens Condominium Association</b> | | Contact Person: |
| Address: <b>13120 Castle Harbour Drive</b> | | Home Phone: |

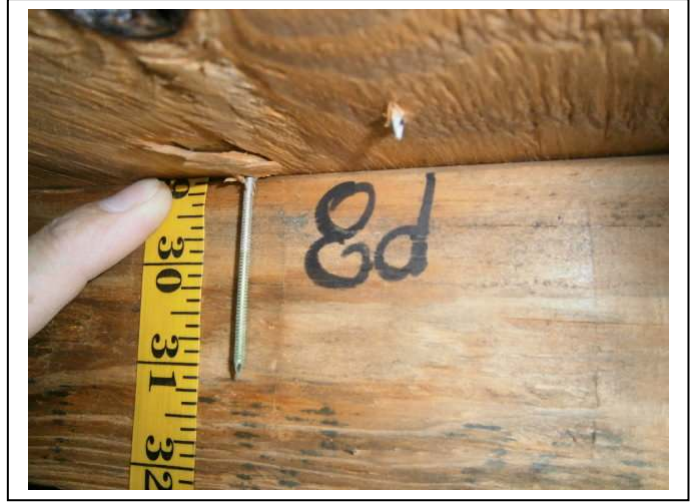
ROOF DECK ATTACHMENT – 8d ring shank  
nails added in 2014

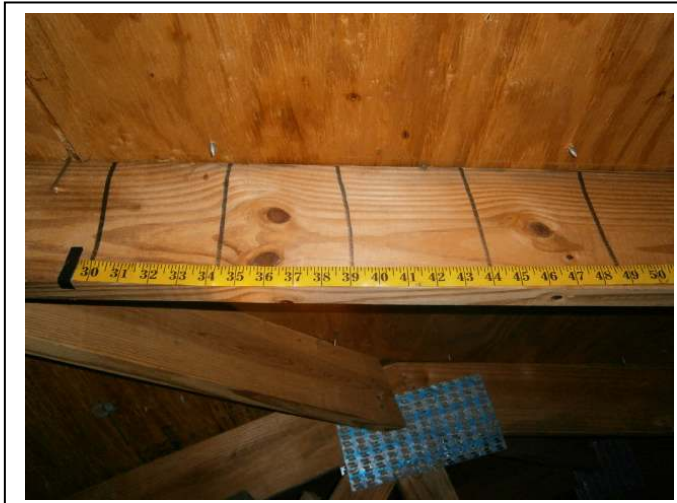
ROOF DECK ATTACHMENT – 8d nails within  
6 inches along the edge

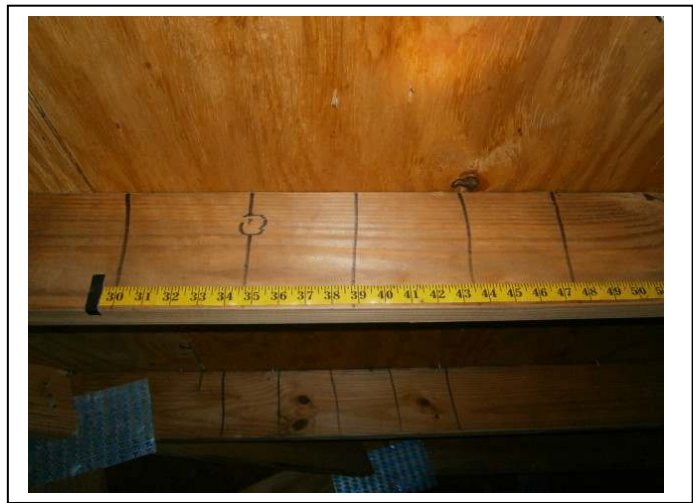
- ☒ C. Plywood/OSB roof sheathing with a minimum thickness of 7/16" inch attached to the roof truss/rafter (spaced a maximum of 24" inches o.c.) by 8d common nails spaced a maximum of 6" inches in the field. -OR- Dimensional lumber/Tongue & Groove decking with a minimum of 2 nails per board (or 1 nail per board if each board is equal to or less than 6 inches in width). -OR- Any system of screws, nails, adhesives, other deck fastening system or truss/rafter spacing that is shown to have an equivalent

ROOF DECK ATTACHMENT – 8d nails within  
6 inches in the field

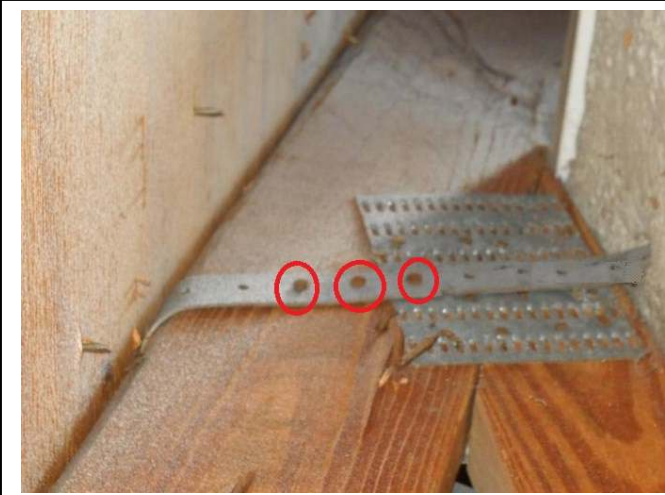
- ☒ C. Single Wraps
  - Metal connectors consisting of a single strap that wraps over the top of the truss/rafter and is secured with a minimum of 2 nails on the front side and a minimum of 1 nail on the opposing side.

ROOF TO WALL ATTACHMENT – Properly installed Single Wraps

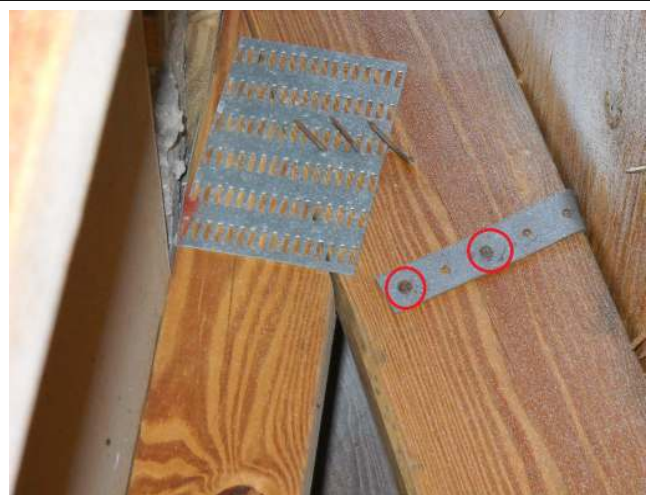
ROOF TO WALL ATTACHMENT – Properly installed Single Wraps

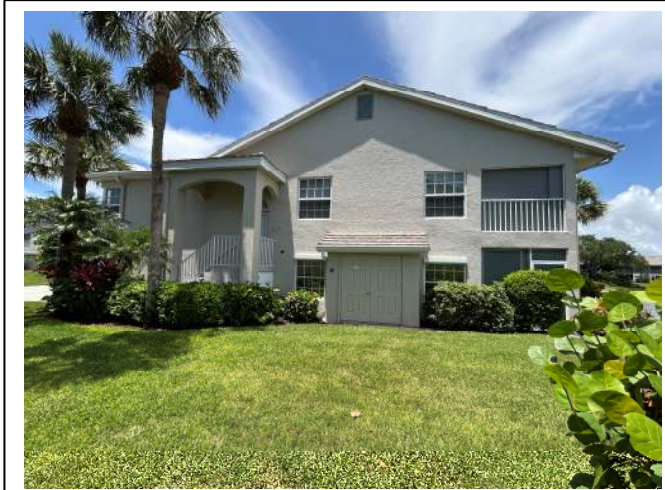
- ☐ A. Hip Roof      Hip roof with no other roof shapes greater than 10% of the total roof system perimeter.  
Total length of non-hip features: \_\_\_\_\_ feet; Total roof system perimeter: \_\_\_\_\_ feet
- ☐ B. Flat Roof      Roof on a building with 5 or more units where at least 90% of the main roof area has a roof slope of less than 2:12. Roof area with slope less than 2:12 \_\_\_\_\_ sq ft; Total roof area \_\_\_\_\_ sq ft
- ☒ C. Other Roof      Any roof that does not qualify as either (A) or (B) above.

ROOF GEOMETRY – Gable / Other Roof Shape

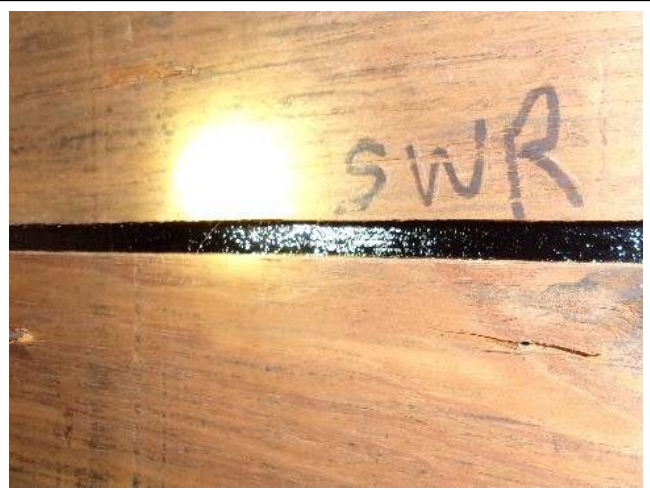
- ☒ A. SWR (also called Sealed Roof Deck) Self-adhering polymer modified-bitumen roofing underlayment applied directly to the sheathing or foam adhesive SWR barrier (not foamed-on insulation) applied as a supplemental means to protect the dwelling from water intrusion in the event of roof covering loss.
- ☐ B. No SWR.
- ☐ C. Unknown or undetermined.

SECONDARY WATER BARRIER – A Peel & Stick adhesive polymer SWR Barrier was installed in 2014 when the covering system was replaced

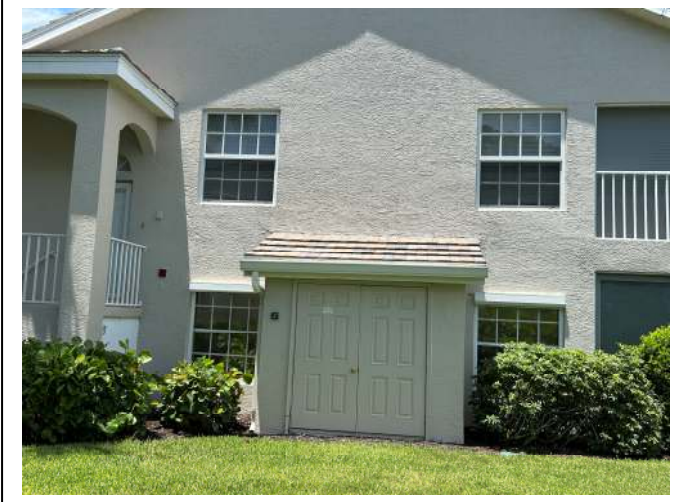
| Opening Protection Level Chart<br>Place an "X" in each row to identify all forms of protection in use for each opening type. Check only one answer below (A thru X), based on the weakest form of protection (lowest row) for any of the Glazed openings and indicate the weakest form of protection (lowest row) for Non-Glazed openings. | | Glazed Openings | | | | Non-Glazed Openings | |
|---|---|---|---|---|---|---|---|
| X | No Windborne Debris Protection | X | | | | X | |

OPENING PROTECTION – Although some unit owners have installed wind-borne debris protection devices, others have not, leaving some of the openings (entry doors, window units & sliding doors) unprotected

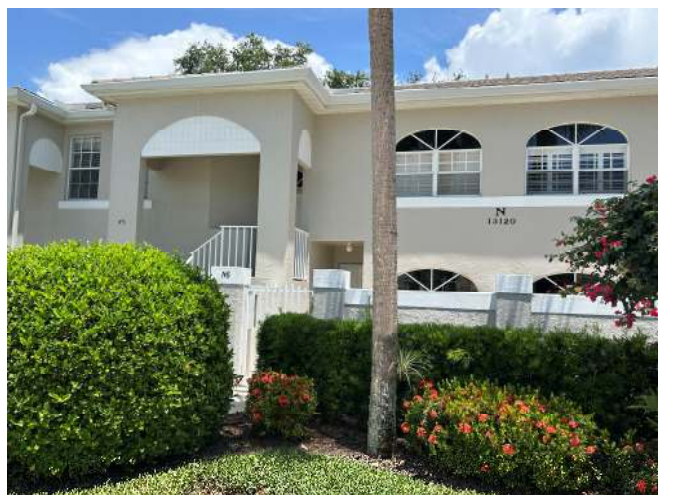
OPENING PROTECTION – Although some unit owners have installed wind-borne debris protection devices, others have not, leaving some of the openings (entry doors, window units & sliding doors) unprotected
