# Uniform Mitigation Verification Inspection Form

| Owner Name: <b>Bermuda Greens Condominium Association</b> | | Contact Person: |
| Address: <b>13141 Hamilton Harbour Drive</b> | | Home Phone: |

## Collier County Re-Roof Permit # PRBD20140305579

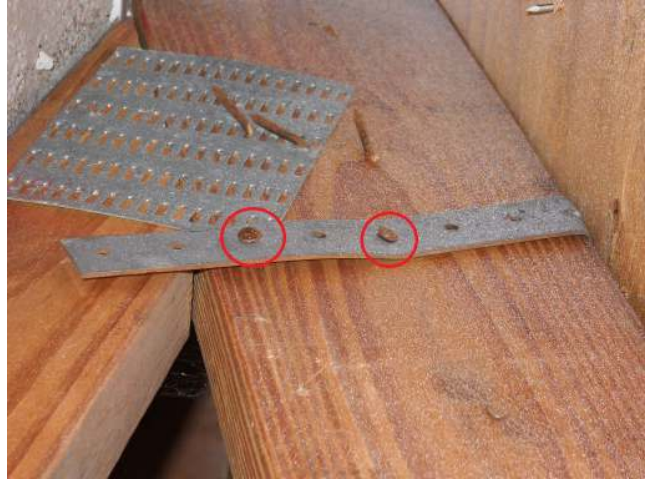
**ROOF TO WALL ATTACHMENT – Properly  
installed Single Wraps**

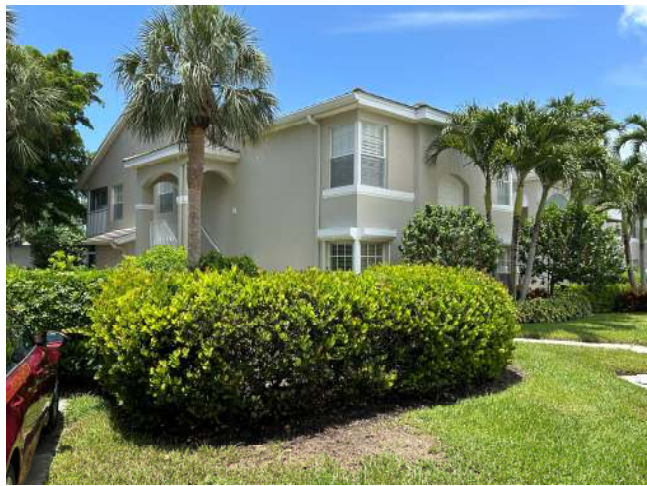
**ROOF GEOMETRY – Gable / Other Roof Shape**

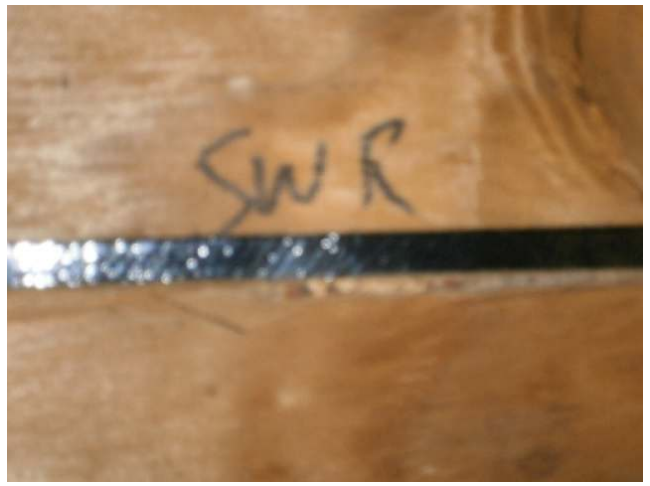
**SECONDARY WATER BARRIER – A Peel &  
Stick adhesive polymer SWR Barrier was  
installed in 2014 when the covering system was  
replaced**

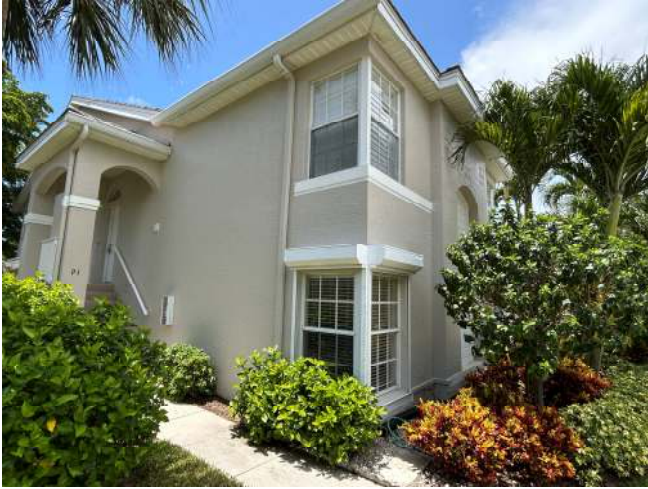
**OPENING PROTECTION** – Although some unit owners have installed wind-borne debris protection devices, others have not, leaving some of the openings (entry doors, window units & sliding doors) unprotected

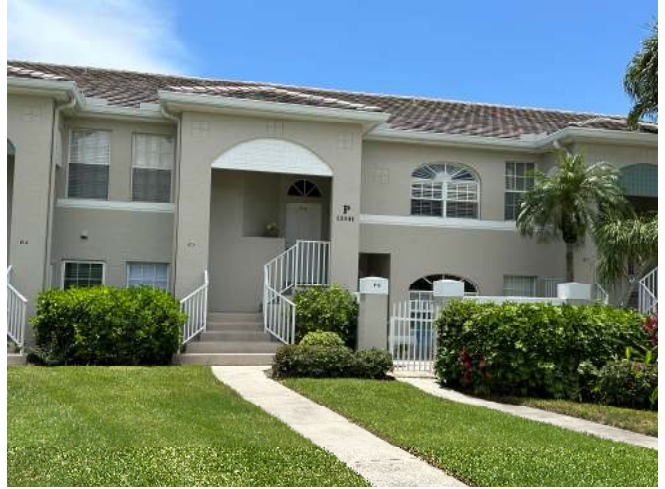
**OPENING PROTECTION** – Although some unit owners have installed wind-borne debris protection devices, others have not, leaving some of the openings (entry doors, window units & sliding doors) unprotected
