FULL RESERVE STUDY

Bermuda Greens Condominium Association, Inc.

**Naples, Florida
September 8, 2020**

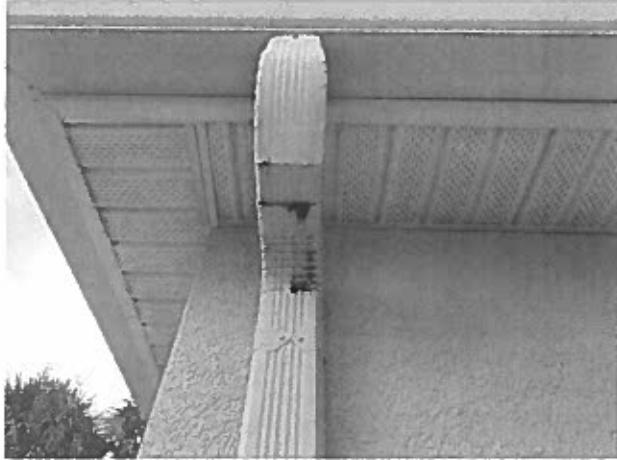
Condition: Good overall with deterioration of the paint finish applications evident

Gutters and downspouts – typical condition – deterioration of the paint finishes evident

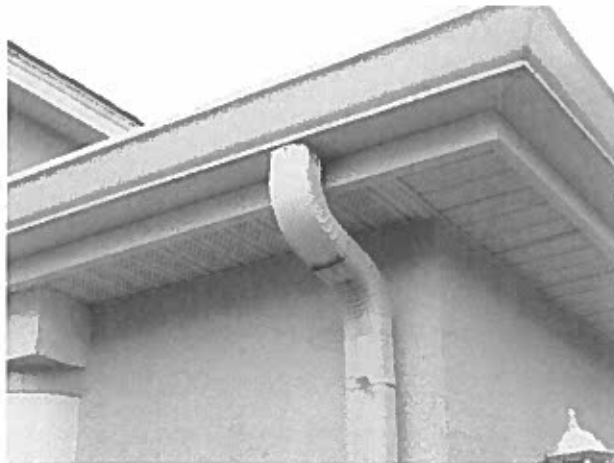
Gutters and downspouts – typical – deterioration of the paint finishes evident

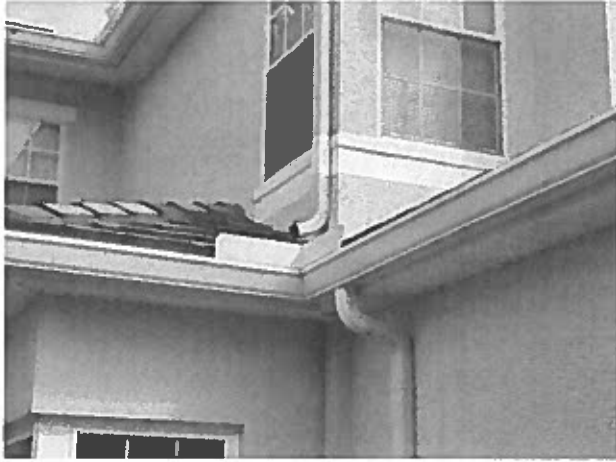
Concrete tile roofs – downspout discharging onto the roof below – this condition could lead to accelerated deterioration of the roofs

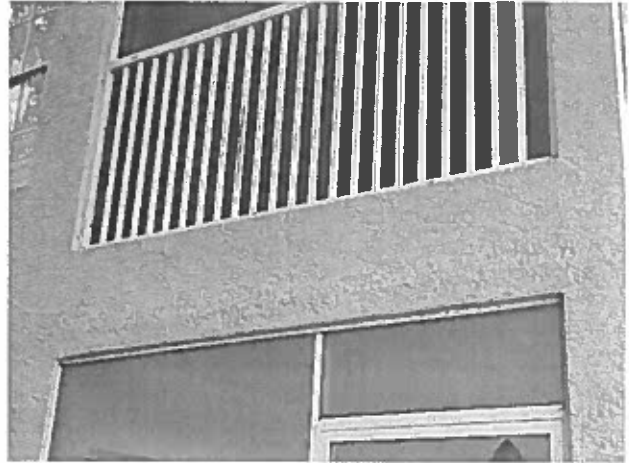
Stucco coated walls – evidence of repairs of the stucco on the rear elevations

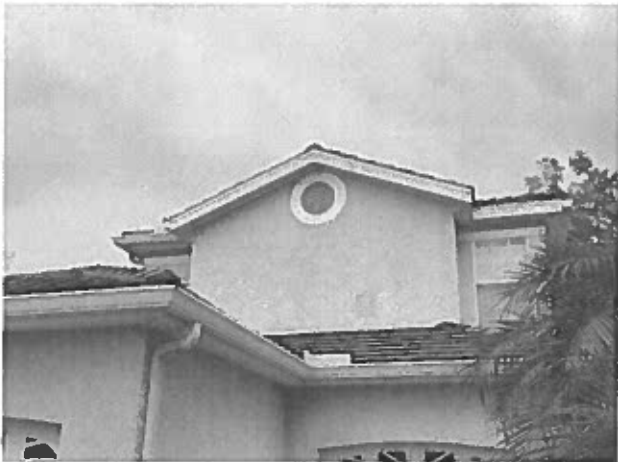
Stucco coated walls – deterioration of the stucco coatings and paint finish applications evident

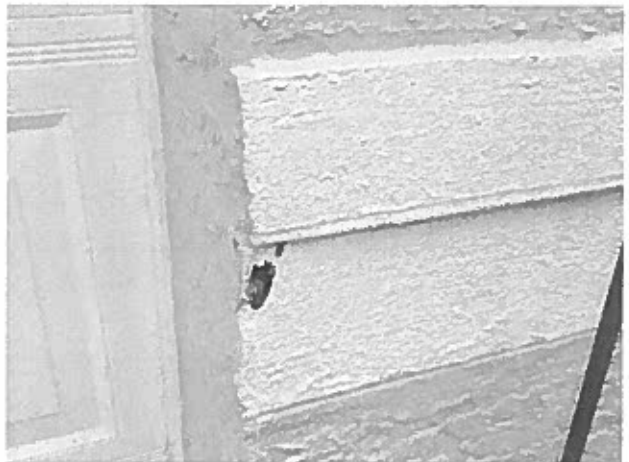
Stucco coated walls – deterioration of the stucco coatings evident

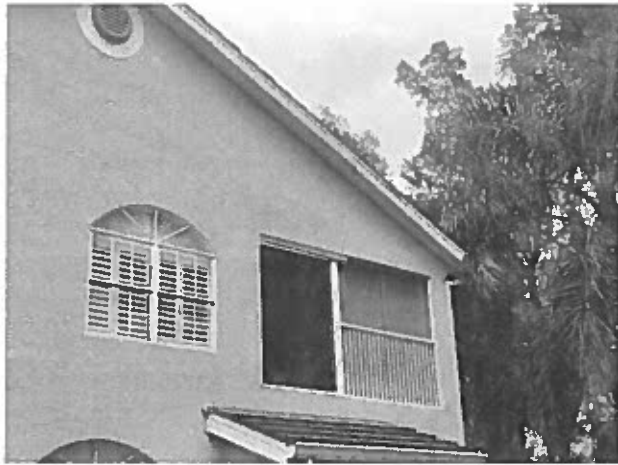
Stucco coated walls – stucco coating repairs evident as well as deterioration of the paint finishes on the fascia evident

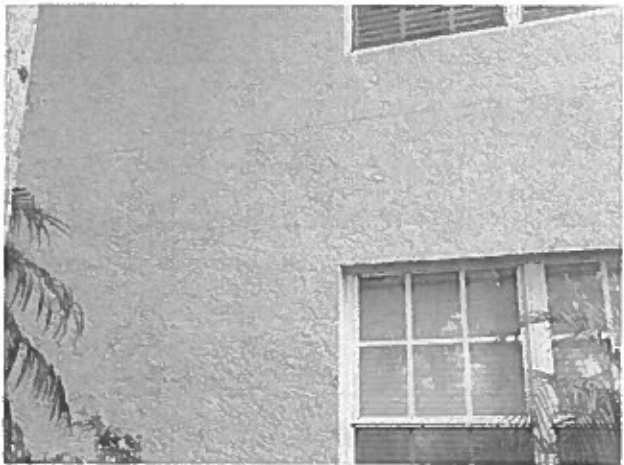
Stucco coated walls – crack repairs evident

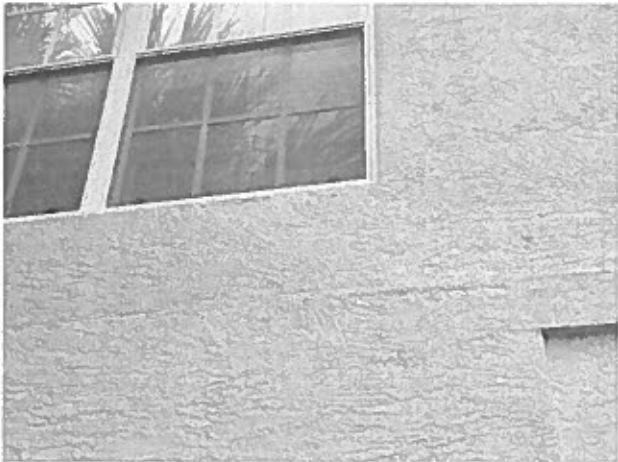
Stucco coated walls – crack repairs evident

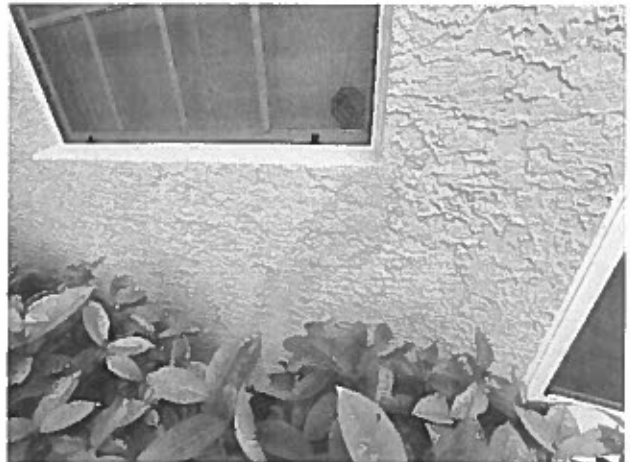
Stucco coated walls – crack repairs evident

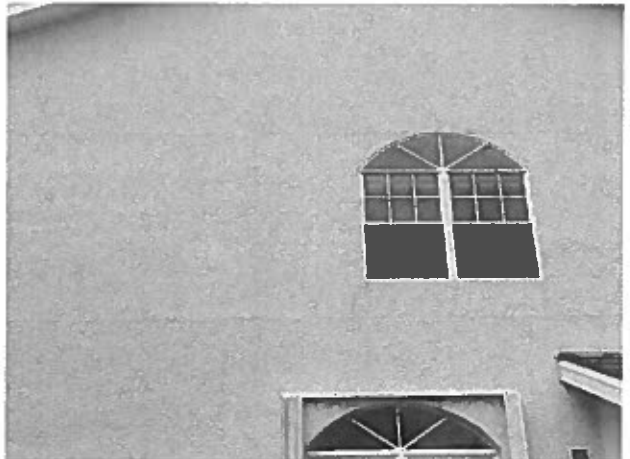
Stucco coated walls – crack repairs evident

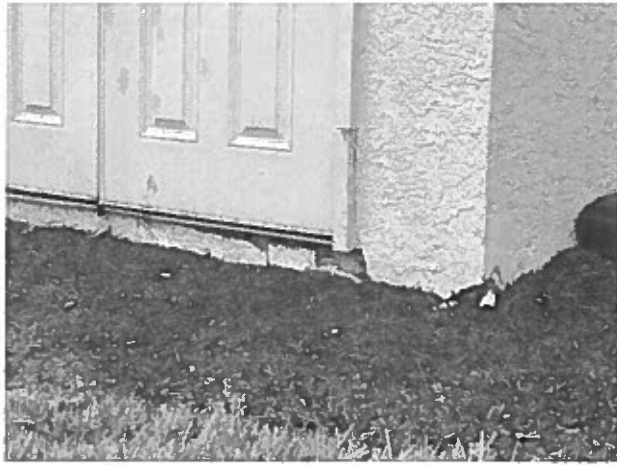
Stucco coated walls – cracks as well as stucco coatings delamination evident

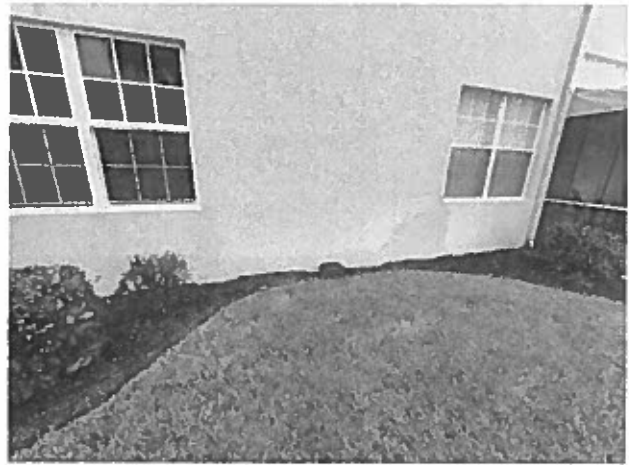
Stucco coated walls – crack repairs and deterioration of the paint finish applications evident

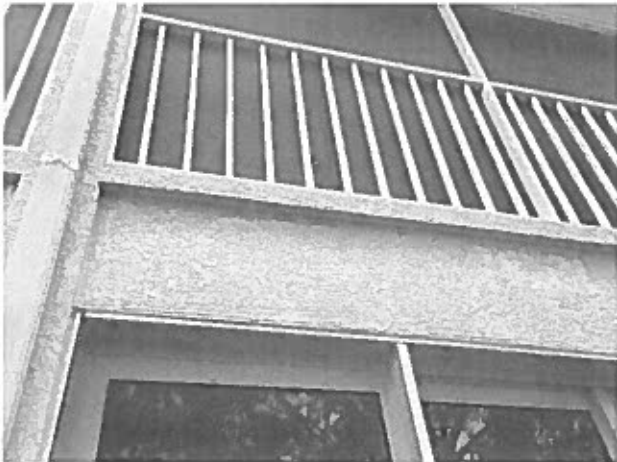
Stucco coated walls – deterioration of the stucco coatings evident

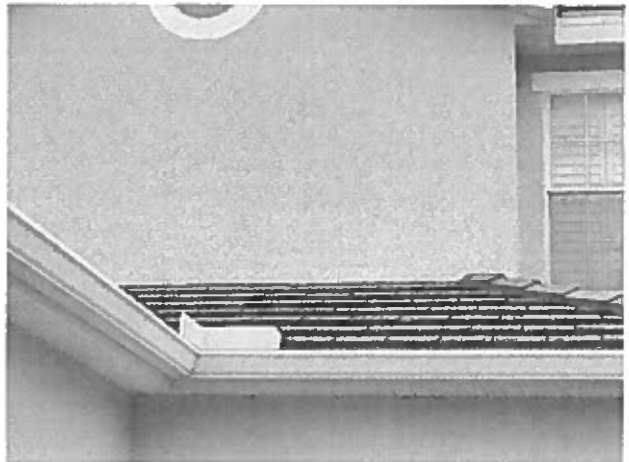
Stucco coated walls – deterioration of the stucco coatings evident

Useful Life: We recommend inspections, repairs and paint finish applications every five- to seven-years. At the request of the Board, we have accelerated inspections and capital repairs to the stucco coatings and paint finish applications.

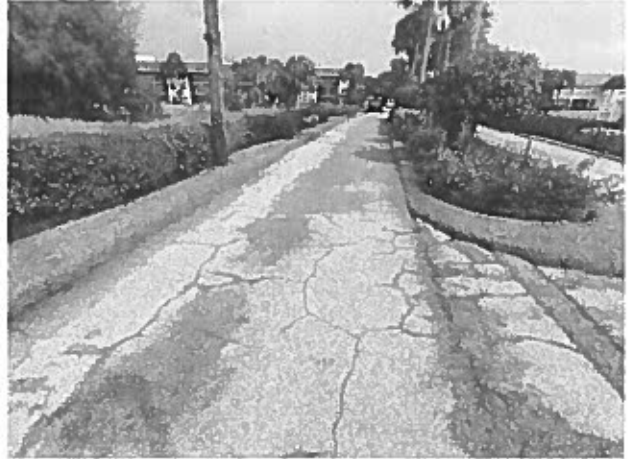
Asphalt pavement – cracks evident

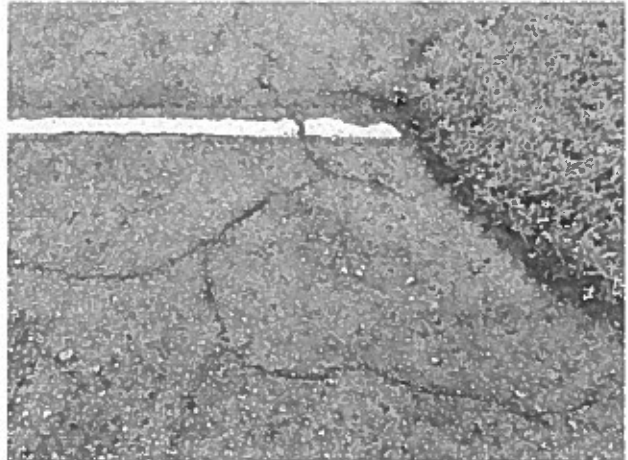
Asphalt pavement – cracks and raveling evident

Useful Life: 15- to 20 –years for repaving of the asphalt pavement. We recommend the Association conduct patch repairs as well as mill and overlyament of the asphalt pavement to be funded through the Operating Budget.

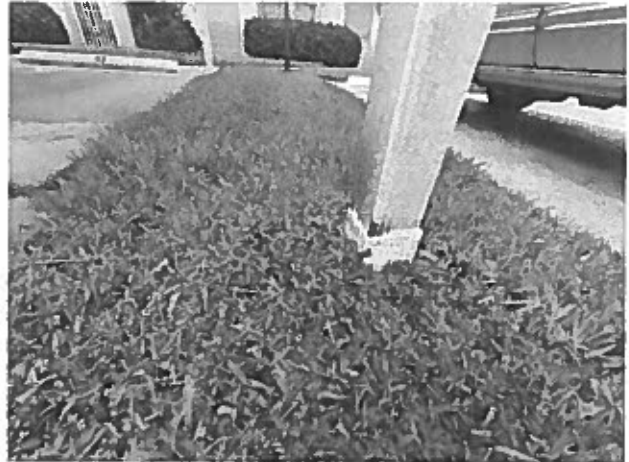
Carport structural column – deterioration of the paint finishes evident

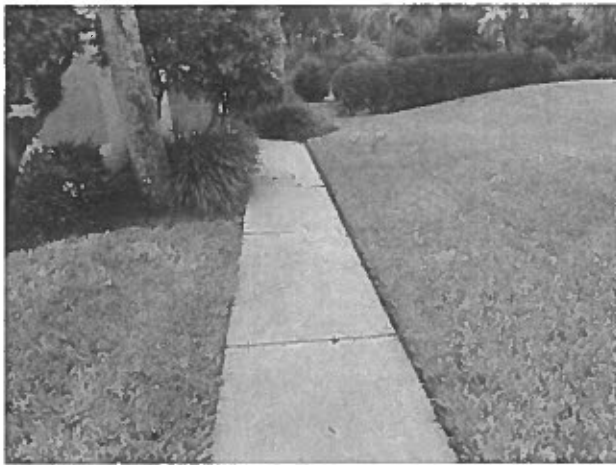
Condition: Good overall with minor uplift evident

Concrete sidewalks – minor uplift evident

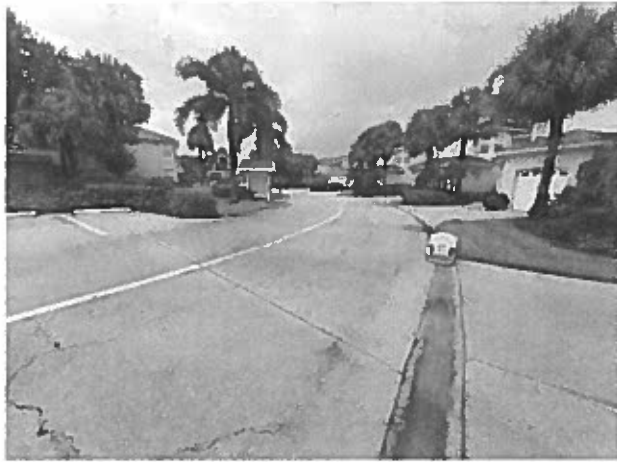
Condition: Fair to poor overall. The Board informs us that the base was improperly constructed. During our inspection we noted significant cracks, deterioration of the concrete, and erosion on the underside of the concrete streets throughout the community. Due to these noted conditions, as well as information provided by the Board, we depict replacement of the remaining concrete street system in the near term. This quantity has been estimated to be approximately 120,500 square feet of concrete streets.

Concrete street system – cracks evident

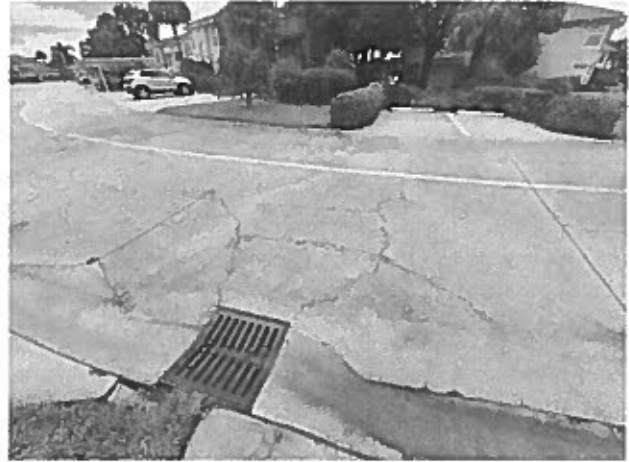
Concrete street system – cracks evident

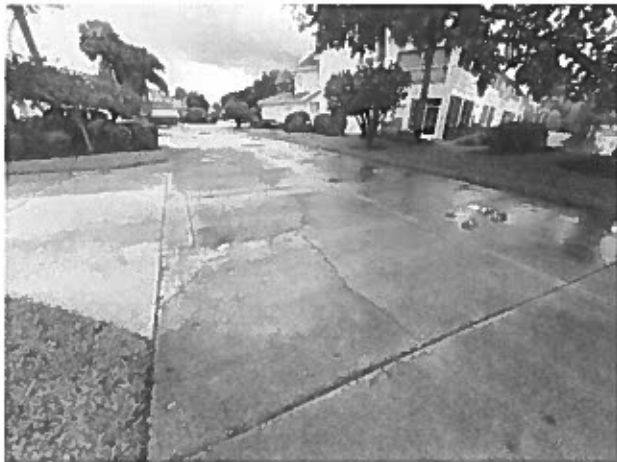
Concrete street system – cracks evident

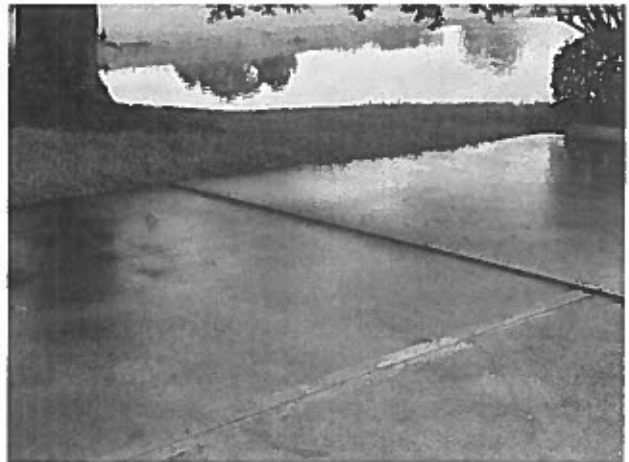
Concrete street system – uplift evident

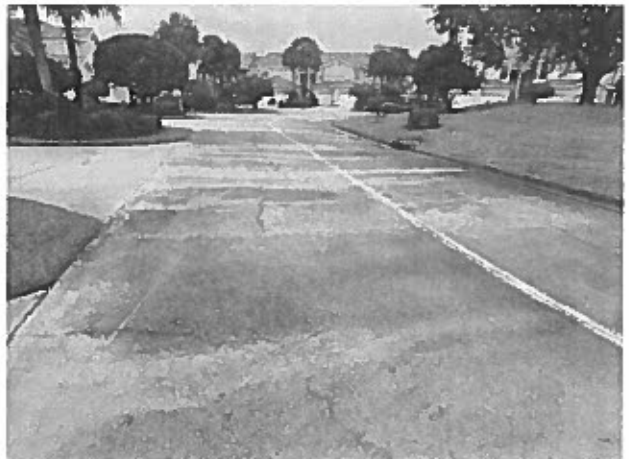
Concrete street system – cracks evident

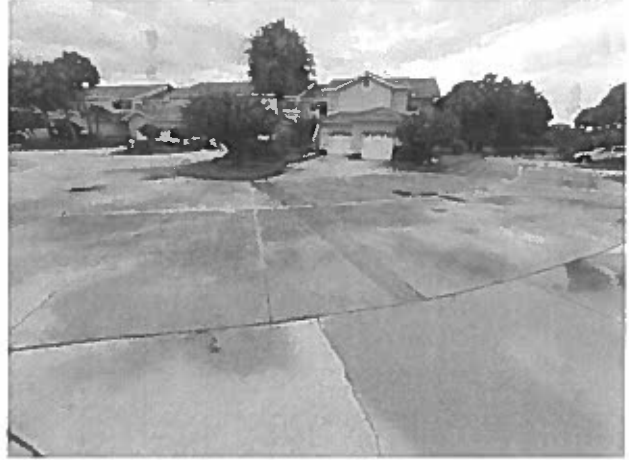
Concrete street system – cracks as well as partial concrete replacement evident – Hamilton Harbour Drive

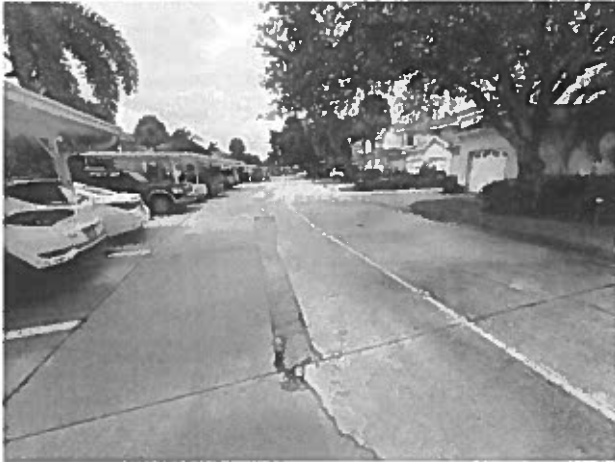
Concrete street system – cracks as well as partial concrete replacement evident

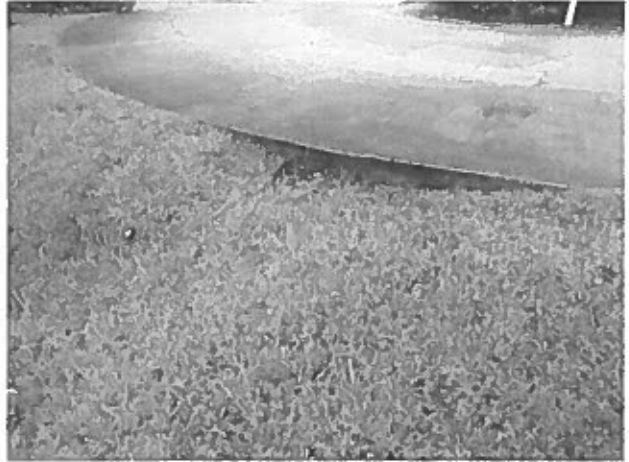
Concrete street system – erosion at Hamilton Harbour Drive evident

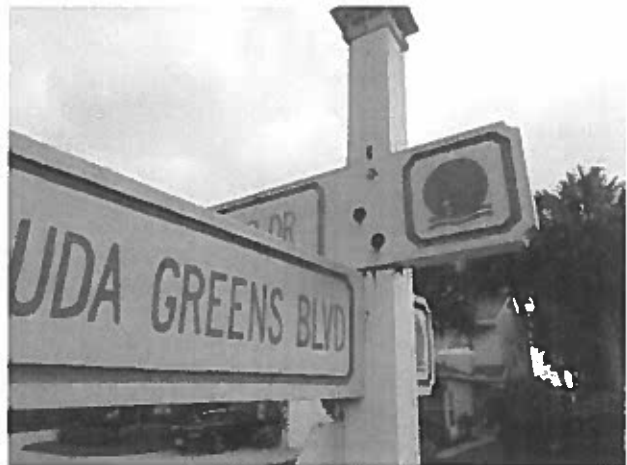
Condition: Good to fair overall with corrosion evident

Street signage – corrosion evident

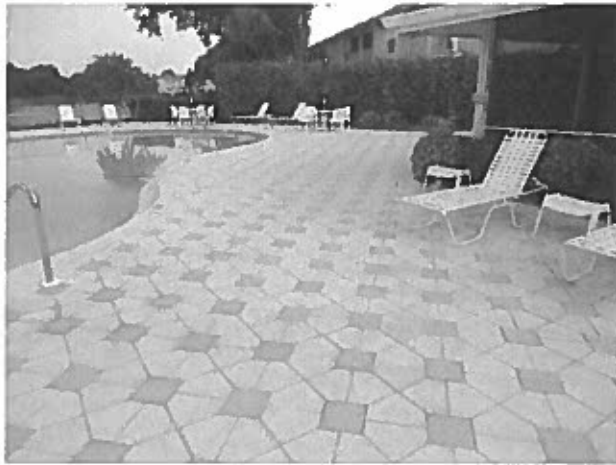
Condition: Fair condition overall. The Board informs us that the deck was improperly constructed due to a lack of proper base material. Due to this, as well as the request of the Board, we have accelerated the replacement of the masonry deck pavers.

Masonry deck pavers - overview

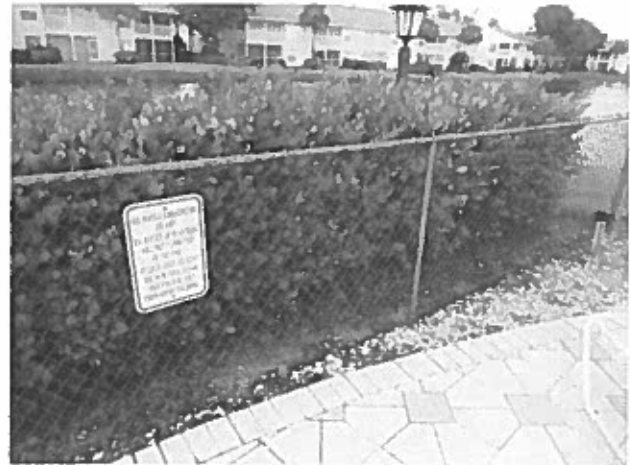
Condition: Good overall condition with deterioration of the finishes evident

Chain link fence – overview – deterioration of the finishes evident
