# Uniform Mitigation Verification Inspection Form

| Owner Name: <b>Bermuda Greens Condominium Association</b> | | Contact Person: |
| Address: <b>13040 Castle Harbour Drive</b> | | Home Phone: |

## Collier County Re-Roof Permit # PRBD20140305583

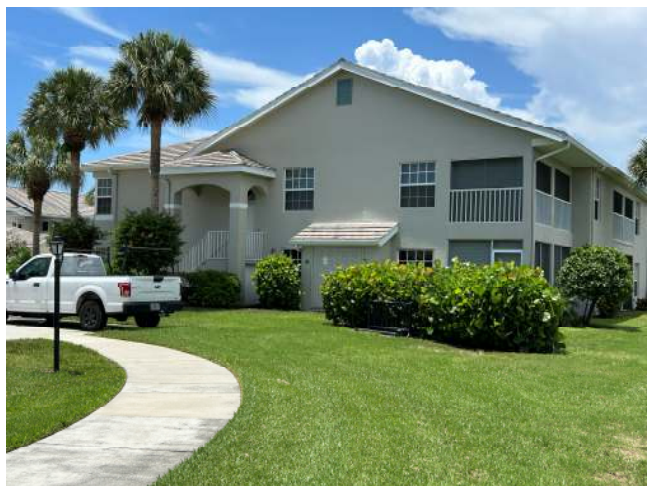
ROOF GEOMETRY – Gable / Other Roof Shape

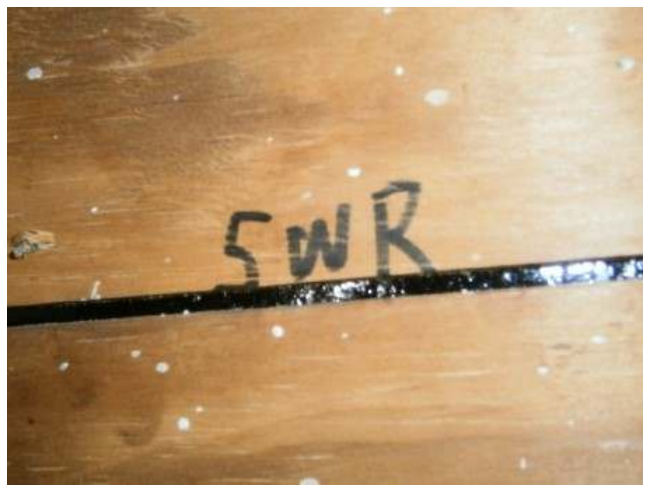
- ☒ A. SWR (also called Sealed Roof Deck) Self-adhering polymer modified-bitumen roofing underlayment applied directly to the sheathing or foam adhesive SWR barrier (not foamed-on insulation) applied as a supplemental means to protect the dwelling from water intrusion in the event of roof covering loss.
- ☐ B. No SWR.
- ☐ C. Unknown or undetermined.

SECONDARY WATER BARRIER – A Peel & Stick adhesive polymer SWR Barrier was installed in 2014 when the covering system was replaced

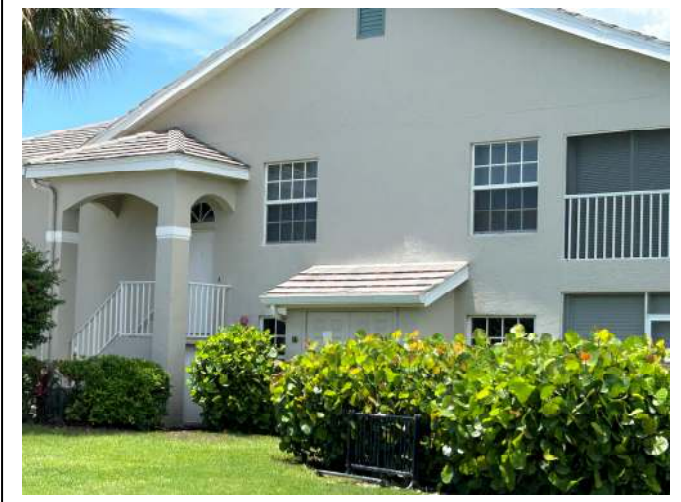
OPENING PROTECTION – Although some unit owners have installed wind-borne debris protection devices, others have not, leaving some of the openings (entry doors, window units & sliding doors) unprotected

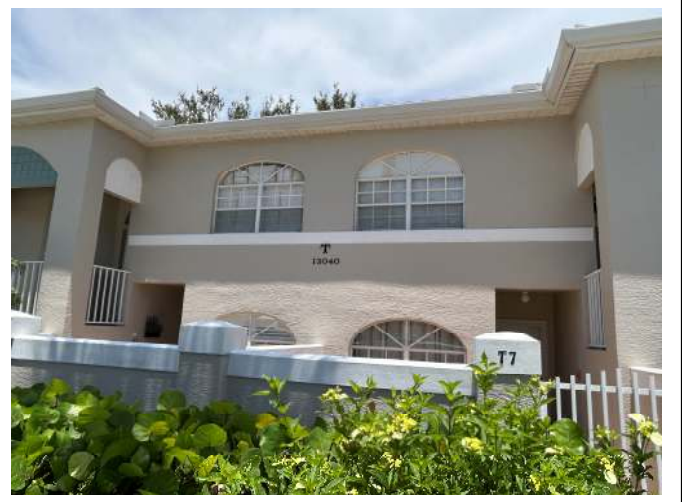
OPENING PROTECTION – Although some unit owners have installed wind-borne debris protection devices, others have not, leaving some of the openings (entry doors, window units & sliding doors) unprotected
