# Uniform Mitigation Verification Inspection Form

Inspection Date: <b>06-10-2025</b>		
<b>Owner Information</b>		
Owner Name: <b>Bermuda Greens Condominium Association</b>		Contact Person:
Address: <b>1600 Bermuda Greens Boulevard</b>		Home Phone:
City: <b>Naples, FL</b>	Zip: <b>34110</b>	Work Phone:
County: <b>Collier</b>		Cell Phone:
Insurance Company:		Policy #:
Year of Home: <b>Completed in 1992</b>	# of Stories: <b>2</b>	Email:

## Collier County Re-Roof Permit # PRBD20140205124

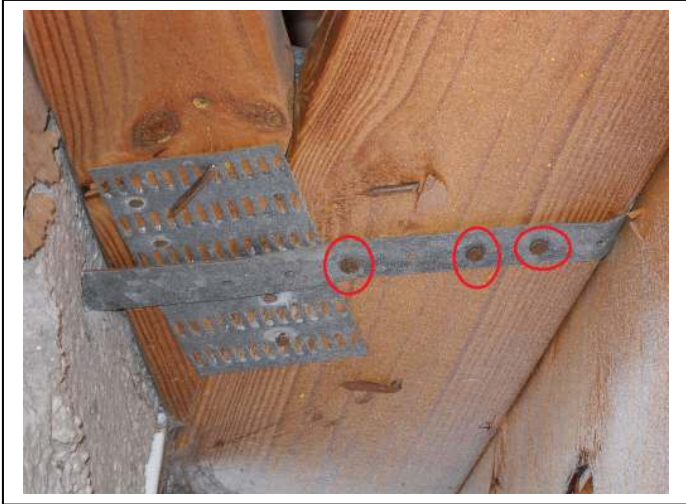
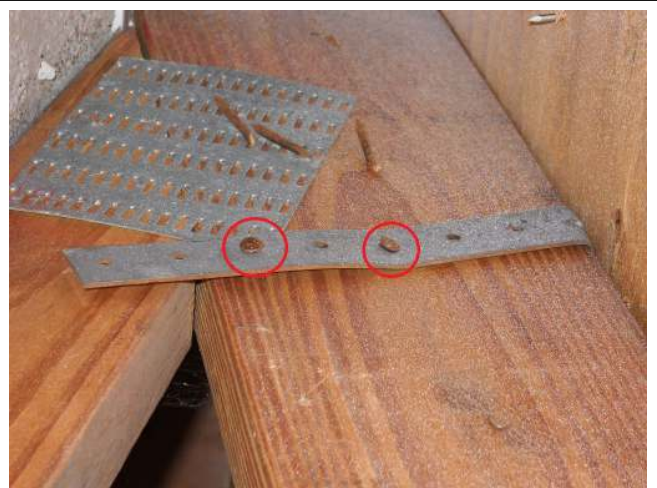
- ☒ C. Single Wraps
  - Metal connectors consisting of a single strap that wraps over the top of the truss/rafter and is secured with a minimum of 2 nails on the front side and a minimum of 1 nail on the opposing side.

**ROOF TO WALL ATTACHMENT – Properly  
installed Single Wraps**

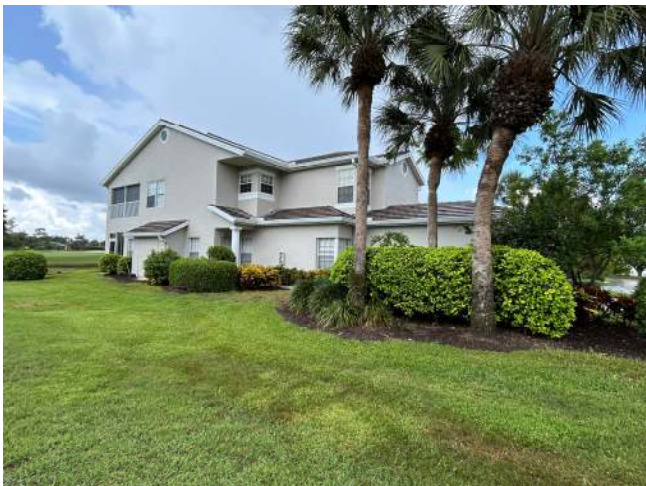
- ☐ A. Hip Roof      Hip roof with no other roof shapes greater than 10% of the total roof system perimeter.  
Total length of non-hip features: \_\_\_\_\_ feet; Total roof system perimeter: \_\_\_\_\_ feet
- ☐ B. Flat Roof      Roof on a building with 5 or more units where at least 90% of the main roof area has a roof slope of less than 2:12. Roof area with slope less than 2:12 \_\_\_\_\_ sq ft; Total roof area \_\_\_\_\_ sq ft
- ☒ C. Other Roof      Any roof that does not qualify as either (A) or (B) above.

**ROOF GEOMETRY – Gable / Other Roof Shape**

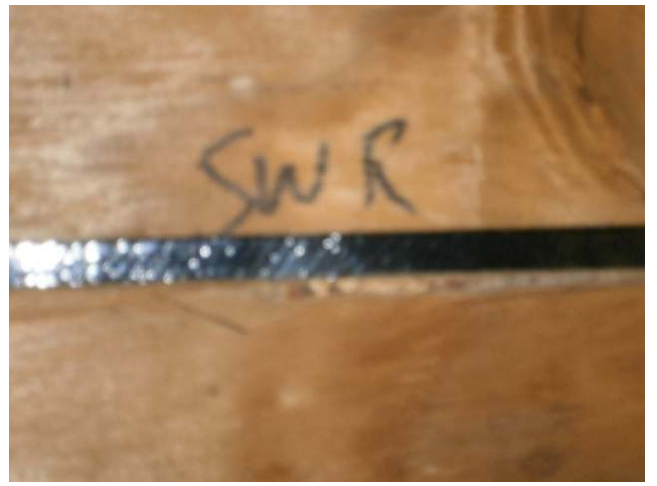
- ☒ A. SWR (also called Sealed Roof Deck) Self-adhering polymer modified-bitumen roofing underlayment applied directly to the sheathing or foam adhesive SWR barrier (not foamed-on insulation) applied as a supplemental means to protect the dwelling from water intrusion in the event of roof covering loss.
- ☐ B. No SWR.
- ☐ C. Unknown or undetermined.

**SECONDARY WATER BARRIER – A Peel &  
Stick adhesive polymer SWR Barrier was  
installed in 2014 when the covering system was  
replaced**

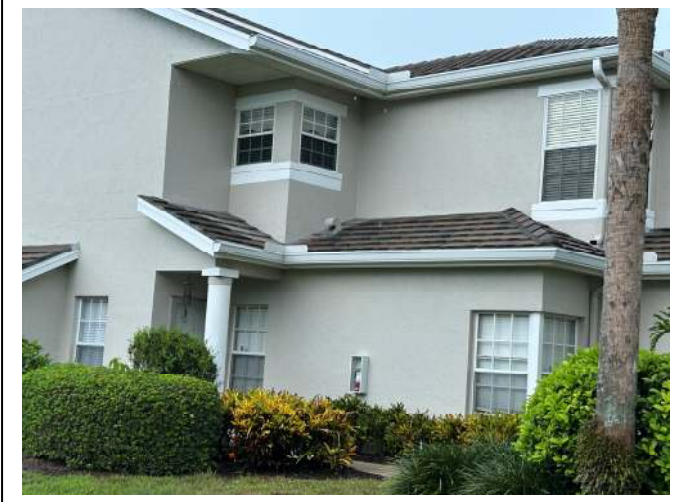
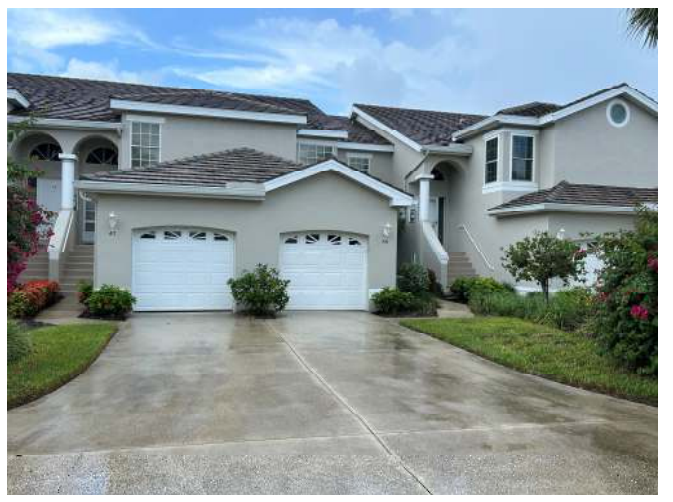
- ☐ **N. Exterior Opening Protection (unverified shutter systems with no documentation)** All Glazed openings are protected with protective coverings not meeting the requirements of Answer "A", "B", or "C" or systems that appear to meet Answer "A" or "B" with no documentation of compliance (Level N in the table above).
- ☐ N.1 All Non-Glazed openings classified as Level A, B, C, or N in the table above, or no Non-Glazed openings exist
- ☐ N.2 One or More Non-Glazed openings classified as Level D in the table above, and no Non-Glazed openings classified as Level X in the table above
- ☐ N.3 One or More Non-Glazed openings is classified as Level X in the table above
- ☒ **X. None or Some Glazed Openings** One or more Glazed openings classified as Level X in the table above.

OPENING PROTECTION – Although some unit owners have installed wind-borne debris protection devices, others have not, leaving some of the openings (entry doors, glazed garage doors, window units & sliding doors) unprotected
