# Uniform Mitigation Verification Inspection Form

| Owner Name: <b>Bermuda Greens Condominium Association</b> | | Contact Person: |
| Address: <b>1651 Bermuda Greens Boulevard</b> | | Home Phone: |
| Year of Home: <b>Completed in 1993</b> | # of Stories: <b>2</b> | Email: |

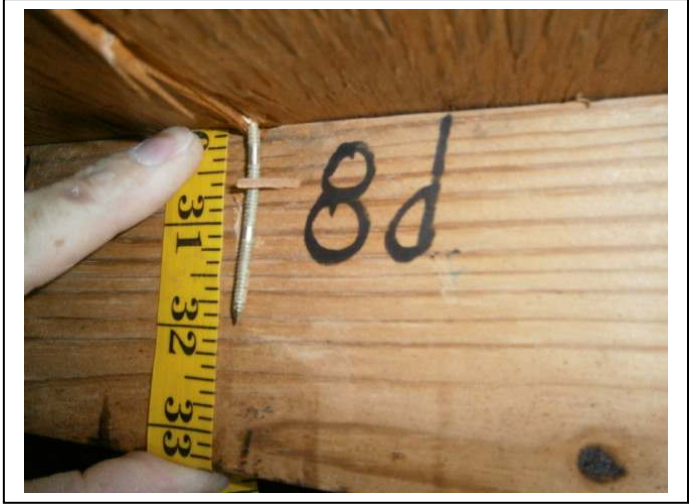
ROOF DECK ATTACHMENT – 8d ring shank nails added in 2014

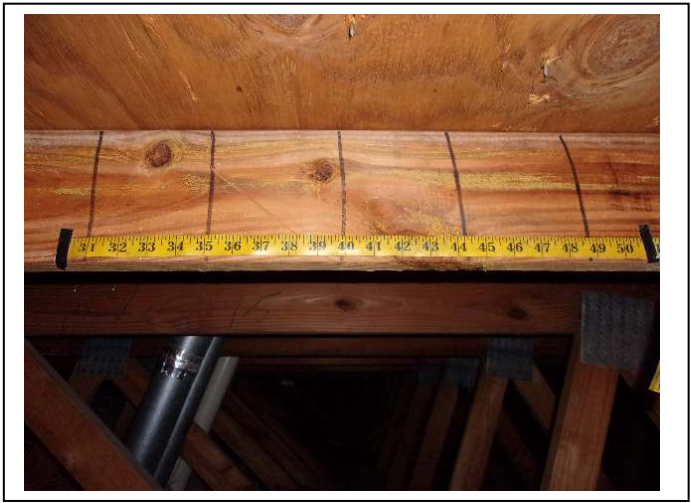
- ☒ C. Plywood/OSB roof sheathing with a minimum thickness of 7/16" inch attached to the roof truss/rafter (spaced a maximum of 24" inches o.c.) by 8d common nails spaced a maximum of 6" inches in the field. -OR- Dimensional lumber/Tongue & Groove decking with a minimum of 2 nails per board (or 1 nail per board if each board is equal to or less than 6 inches in width). -OR- Any system of screws, nails, adhesives, other deck fastening system or truss/rafter spacing that is shown to have an equivalent

ROOF DECK ATTACHMENT – 8d nails within 6 inches in the field

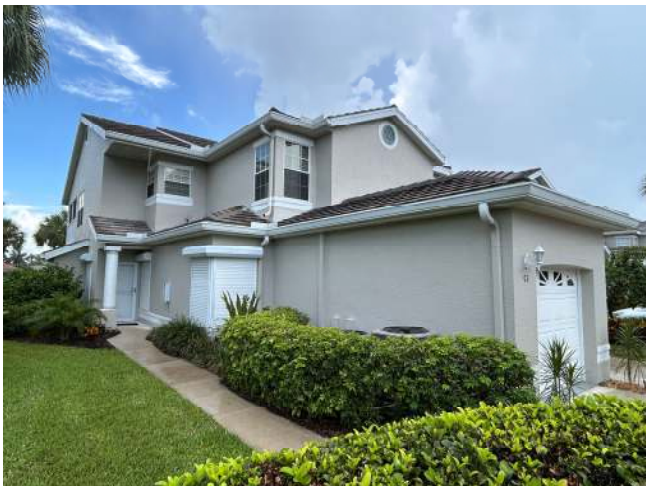
**ROOF GEOMETRY – Gable / Other Roof Shape**

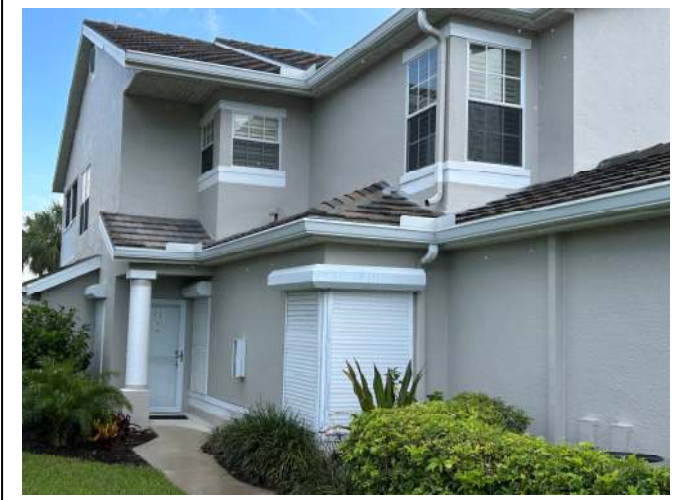
**OPENING PROTECTION** – Although some unit owners have installed wind-borne debris protection devices, others have not, leaving some of the openings (entry doors, glazed garage doors, window units & sliding doors) unprotected

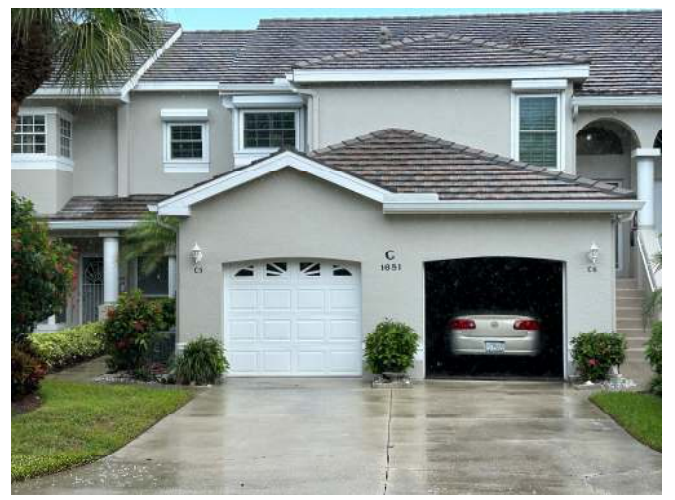
- ☐ **N. Exterior Opening Protection (unverified shutter systems with no documentation)** All Glazed openings are protected with protective coverings not meeting the requirements of Answer "A", "B", or "C" or systems that appear to meet Answer "A" or "B" with no documentation of compliance (Level N in the table above).
- ☐ N.1 All Non-Glazed openings classified as Level A, B, C, or N in the table above, or no Non-Glazed openings exist
- ☐ N.2 One or More Non-Glazed openings classified as Level D in the table above, and no Non-Glazed openings classified as Level X in the table above
- ☐ N.3 One or More Non-Glazed openings is classified as Level X in the table above
- ☒ **X. None or Some Glazed Openings** One or more Glazed openings classified as Level X in the table above.

**OPENING PROTECTION** – Although some unit owners have installed wind-borne debris protection devices, others have not, leaving some of the openings (entry doors, glazed garage doors, window units & sliding doors) unprotected
