# Uniform Mitigation Verification Inspection Form

| Inspection Date: <b>06-10-2025</b> | | |
| Owner Name: <b>Bermuda Greens Condominium Association</b> | | Contact Person: |
| Address: <b>1695 Bermuda Greens Boulevard</b> | | Home Phone: |

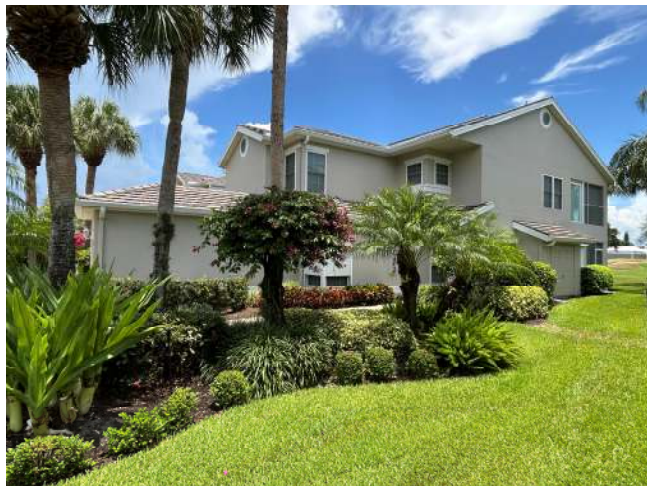
- ☐ A. Hip Roof      Hip roof with no other roof shapes greater than 10% of the total roof system perimeter.  
Total length of non-hip features: \_\_\_\_\_ feet; Total roof system perimeter: \_\_\_\_\_ feet
- ☐ B. Flat Roof      Roof on a building with 5 or more units where at least 90% of the main roof area has a roof slope of less than 2:12. Roof area with slope less than 2:12 \_\_\_\_\_ sq ft; Total roof area \_\_\_\_\_ sq ft
- ☒ C. Other Roof      Any roof that does not qualify as either (A) or (B) above.

ROOF GEOMETRY – Gable / Other Roof Shape

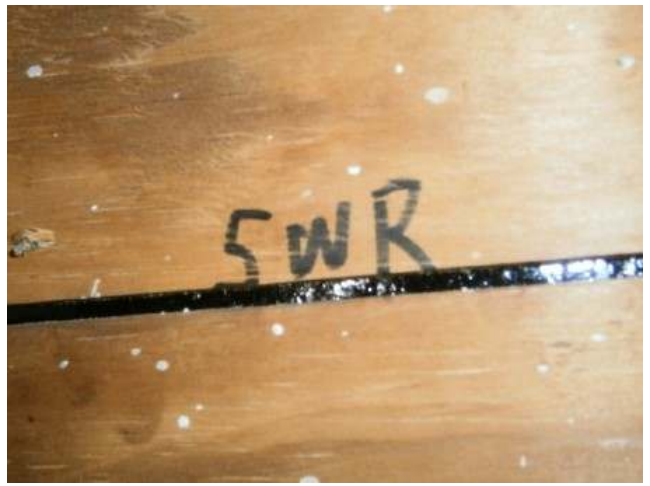
- ☒ A. SWR (also called Sealed Roof Deck) Self-adhering polymer modified-bitumen roofing underlayment applied directly to the sheathing or foam adhesive SWR barrier (not foamed-on insulation) applied as a supplemental means to protect the dwelling from water intrusion in the event of roof covering loss.
- ☐ B. No SWR.
- ☐ C. Unknown or undetermined.

SECONDARY WATER BARRIER – A Peel & Stick adhesive polymer SWR Barrier was installed in 2014 when the covering system was replaced

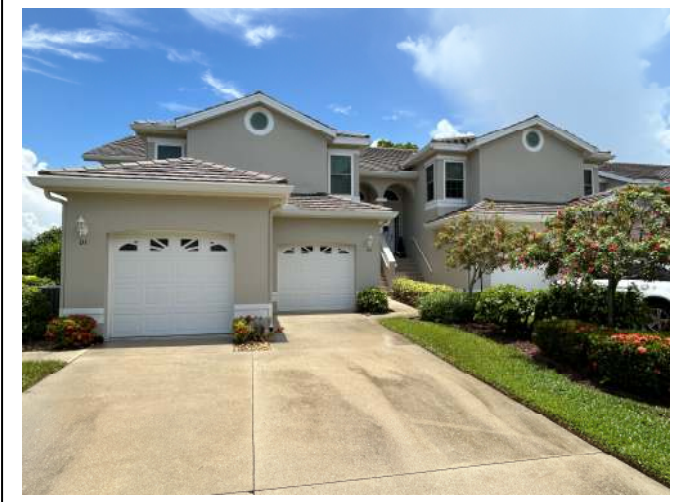
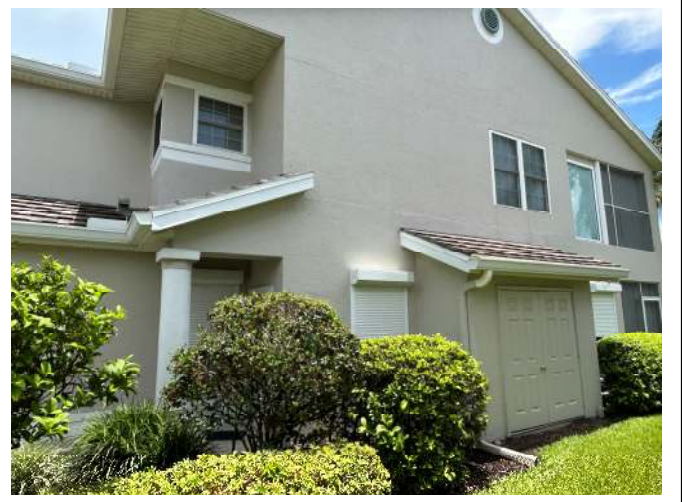
| Opening Protection Level Chart<br>Place an "X" in each row to identify all forms of protection in use for each opening type. Check only one answer below (A thru X), based on the weakest form of protection (lowest row) for any of the Glazed openings and indicate the weakest form of protection (lowest row) for Non-Glazed openings. | | Glazed Openings | | | | Non-Glazed Openings | |
|---|---|---|---|---|---|---|---|
| X | No Windborne Debris Protection | X | X | | | X | X |

OPENING PROTECTION – Although some unit owners have installed wind-borne debris protection devices, others have not, leaving some of the openings (entry doors, glazed garage doors, window units & sliding doors) unprotected
