FULL RESERVE STUDY

Bermuda Greens Condominium Association, Inc.

**Naples, Florida
September 8, 2020**

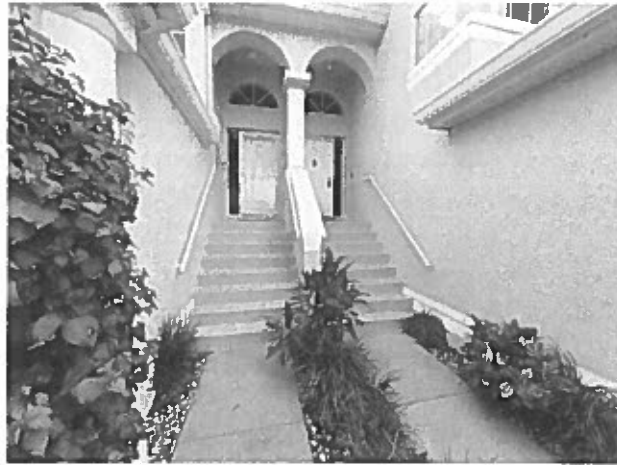
Condition: Good overall

Entrance doors and sidelight windows - typical

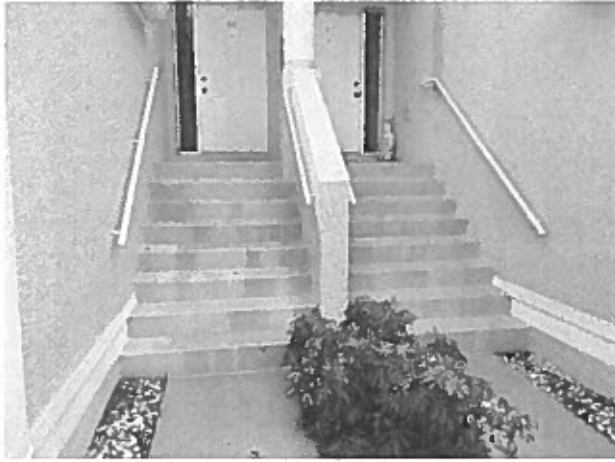
Condition: The concrete stairs as well as the waterproof coating applications are in good condition overall

Concrete stairs – garage units – overview

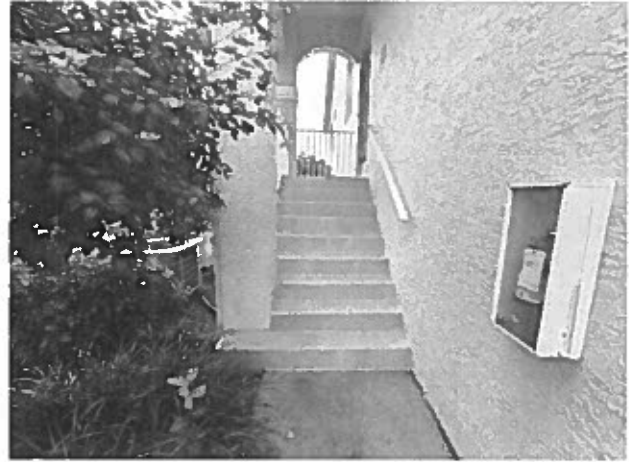
Concrete stairs – carport units - overview

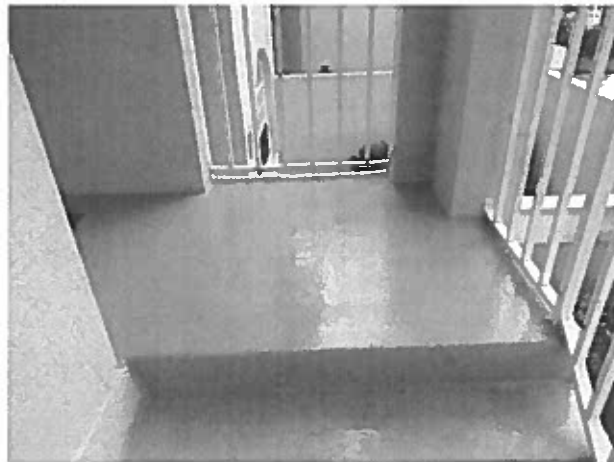
**Concrete waterproof coating applications –
typical condition**

Useful Life: Capital repairs including a close-up visual inspection, patching of delaminated concrete, routing and filling of cracked concrete, and waterproof coating applications every 8- to 12-years. We depict applications of waterproof coatings to be done in conjunction with every other paint finish application event.

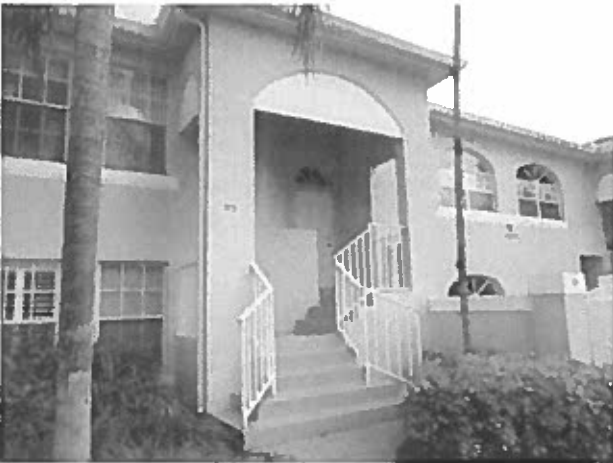
Condition: Good condition overall

Railings – carport units – typical configuration

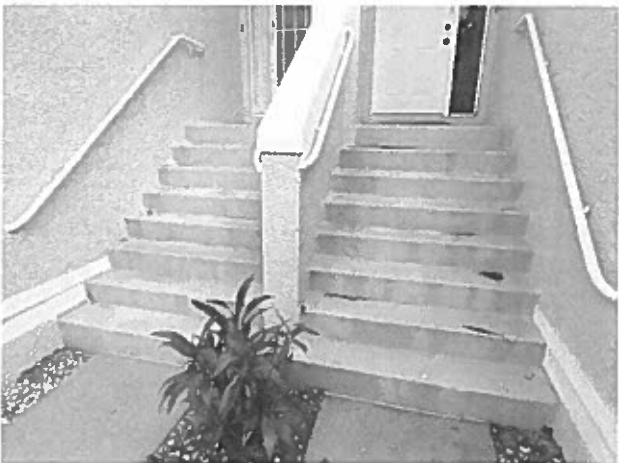
Railings – garage units – typical configuration

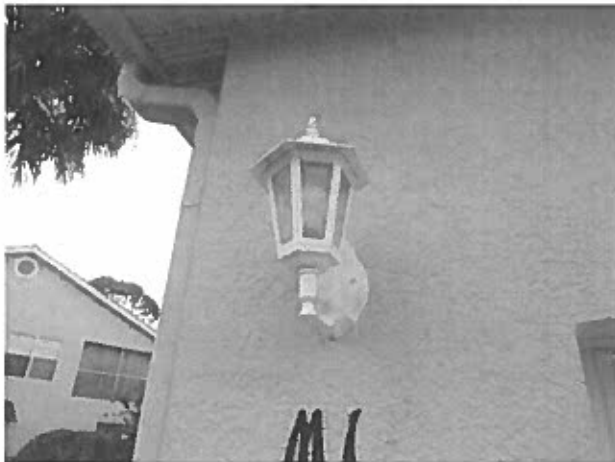
Condition: Good overall

Light fixtures – garage units – garage - typical

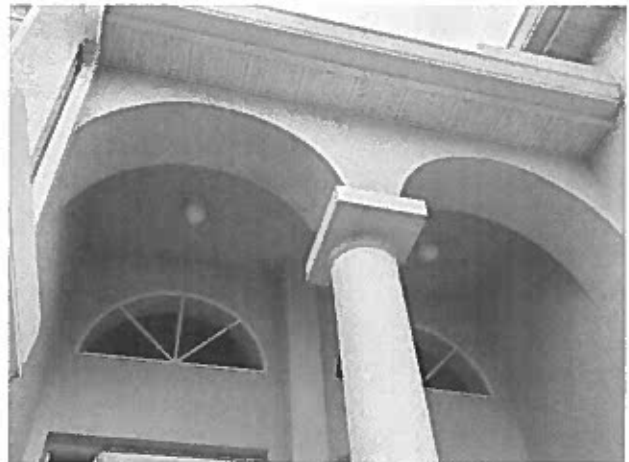
Light fixtures – garage units – entrances - typical

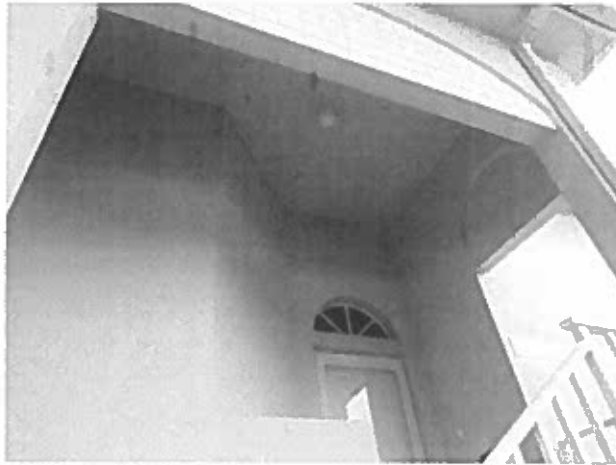
Light fixtures – carport units – entrances -
typical

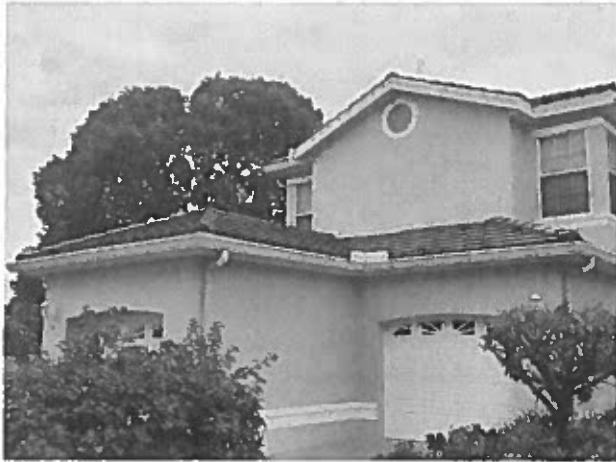
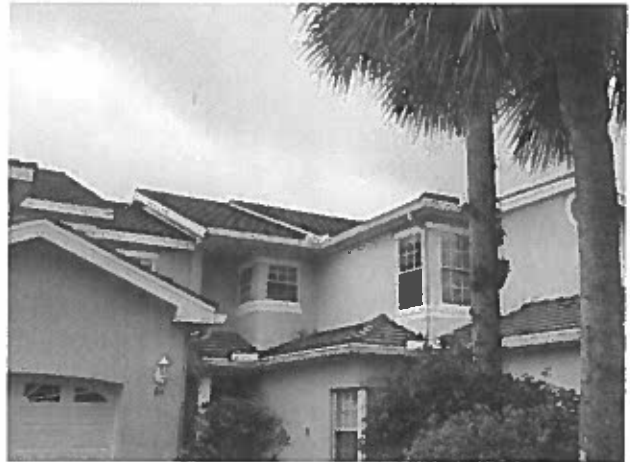
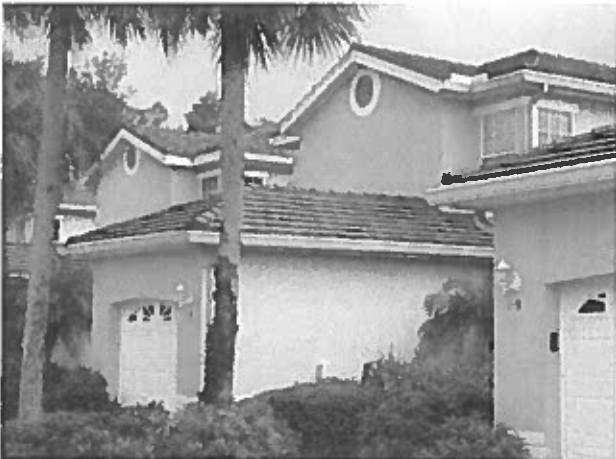
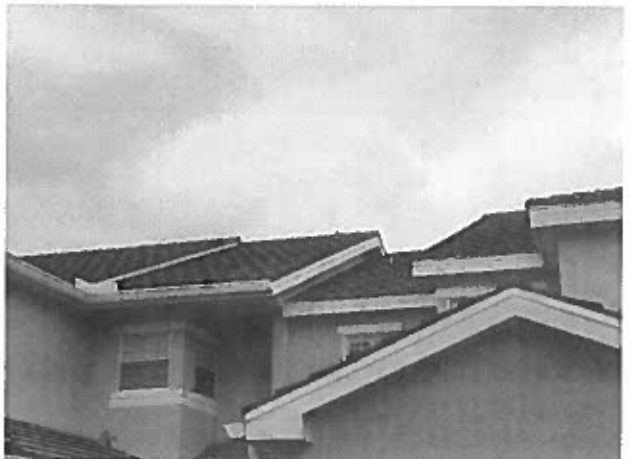
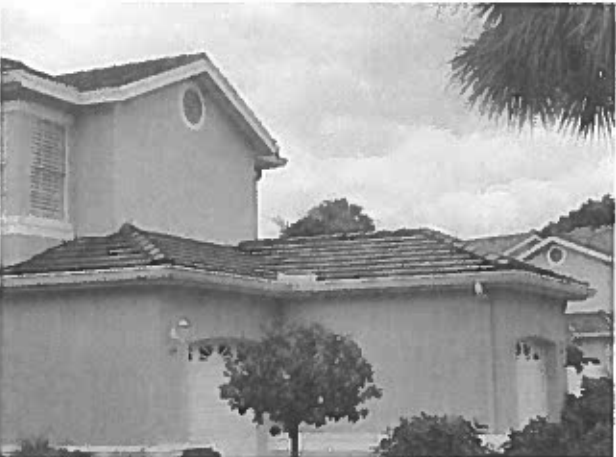
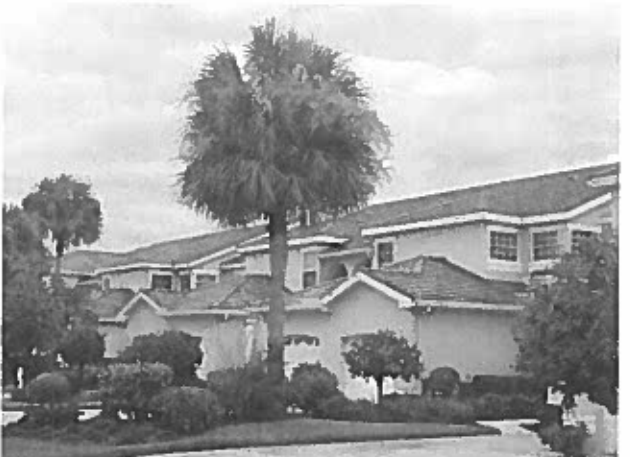
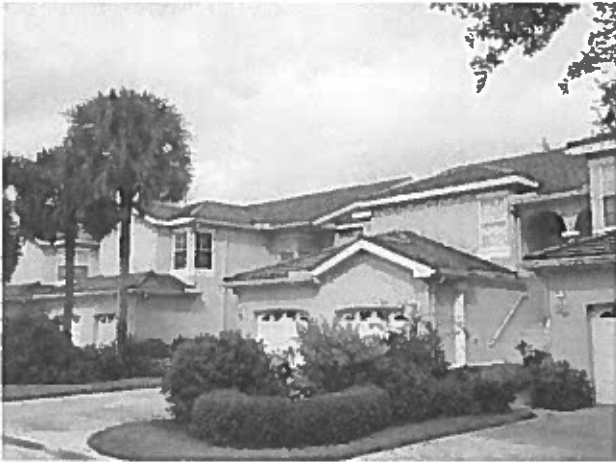
Condition: The Board informs us of significant issues with roof leaks. Due to this, we have accelerated the replacement of the concrete tile roofs. Additionally, at the request of the Board, we have included an allowance in order to create an inspection and capital repairs program for the concrete tile roofs in the near term. Future updates to this Reserve Study should consider any changes in this inspections and capital repairs program as the concrete tile roofs continue to age.

Concrete tile roofs – garage unit - typical

Useful Life: Up to 30 years for the replacement of concrete tile roofs. Due to information provided by the Board, we have accelerated the replacement of the concrete tile roofs.

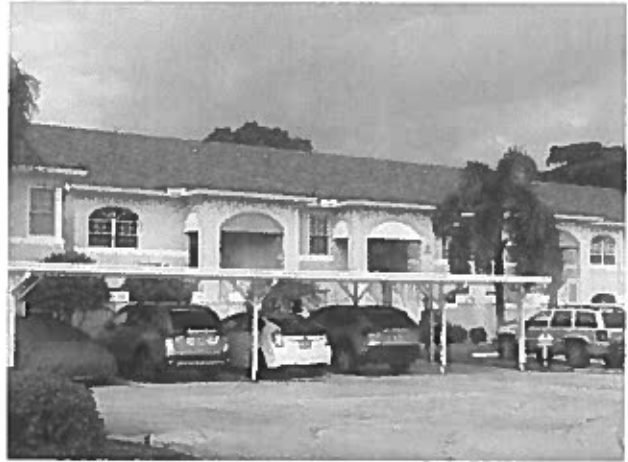
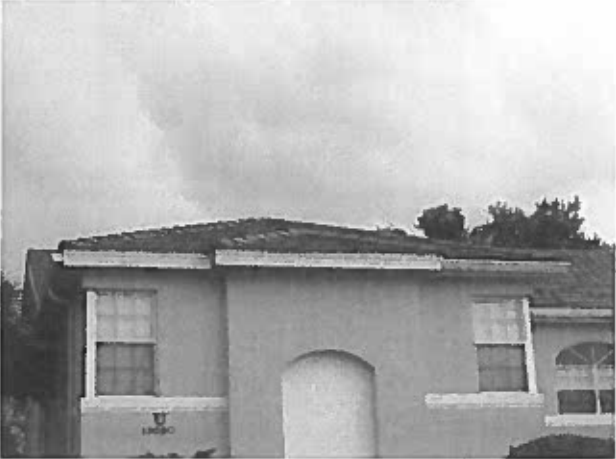
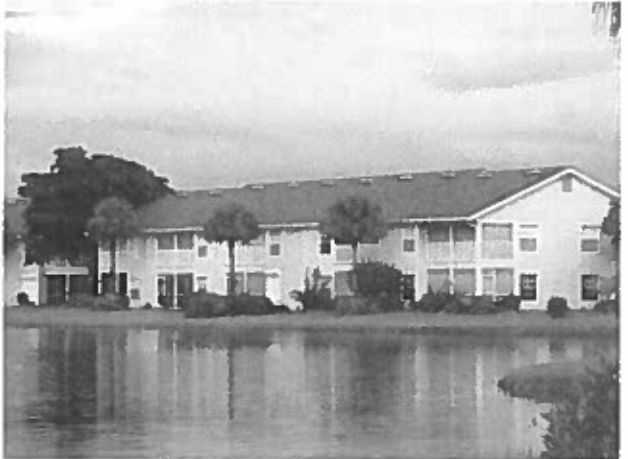
Concrete tile roofs – carport units - typical

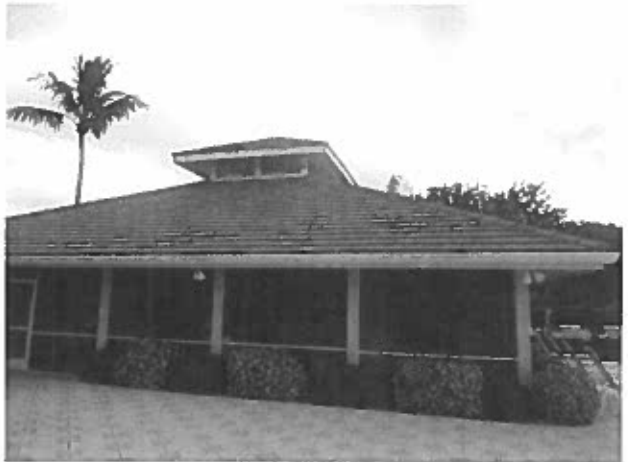
Concrete tile roofs – clubhouse - typical

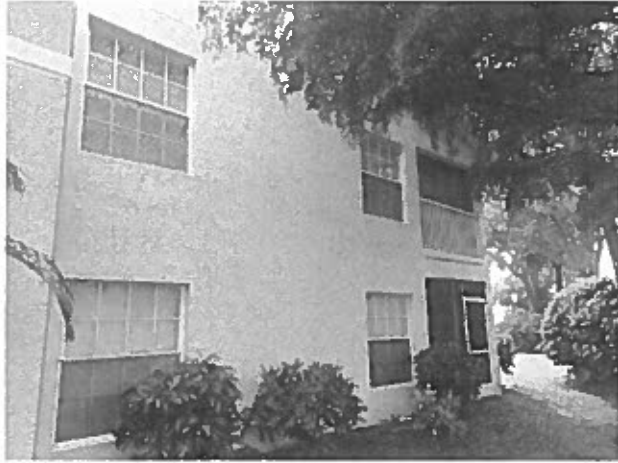
Condition: The stucco coating and paint finish applications appeared in good to fair condition with evidence of crack repairs, cracks, delamination of the stucco, and deterioration of the paint finish applications evident during our inspection. The Board informs us of ongoing issues with cracks developing in stucco coatings as well as corrosion evident, in particular at the bands along the rear of the residential buildings. At the request of the Board we have included an allowance for inspections of the stucco coatings.

Stucco coated walls – overall – carport units

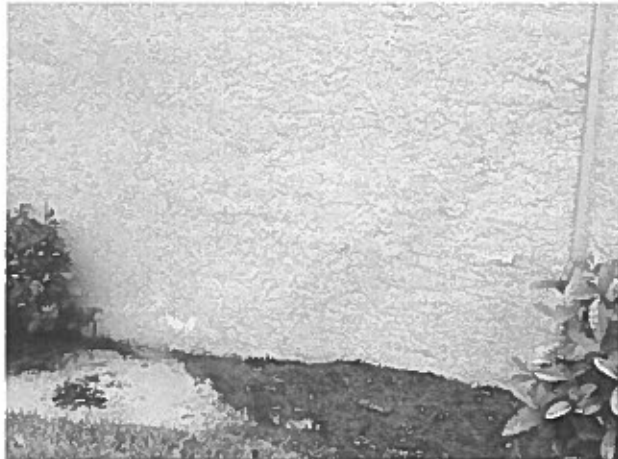
Stucco coated walls – crack repairs and deterioration of the paint finish applications evident

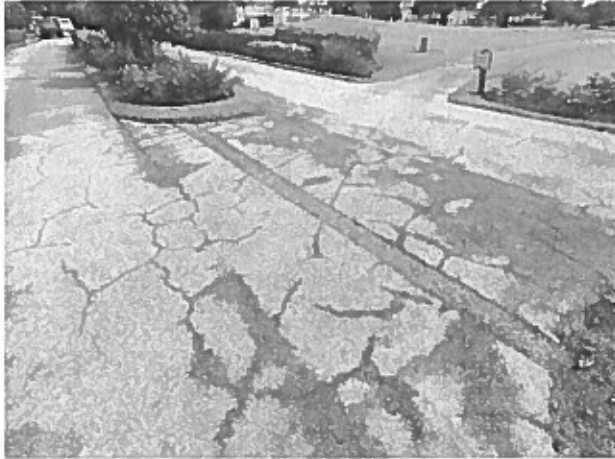
Condition: Good to fair overall with cracks and raveling evident

Asphalt pavement – cracks evident

Useful Life: 15- to 20 –years for repaving of the asphalt pavement. We recommend the Association conduct patch repairs as well as mill and overlyament of the asphalt pavement to be funded through the Operating Budget.

The manner of repaving is either a mill and overlay or total replacement. A mill and overlay is a method of repaving where cracked, worn and failed pavement is mechanically removed or milled until sound pavement is found. A new layer of asphalt is overlaid atop the remaining base course of pavement. Total replacement includes the removal of all existing asphalt down to the base course of aggregate and native soil followed by the application of two or more new lifts of asphalt. We recommend mill and overlayment on asphalt pavement that exhibits normal deterioration and wear. We recommend total replacement of asphalt pavement that exhibits severe deterioration, inadequate drainage, pavement that has been overlaid multiple times in the past or where the configuration makes overlayment not possible. Based on the apparent visual condition and configuration of the asphalt pavement, we recommend the total replacement method of repaving at Bermuda Greens.

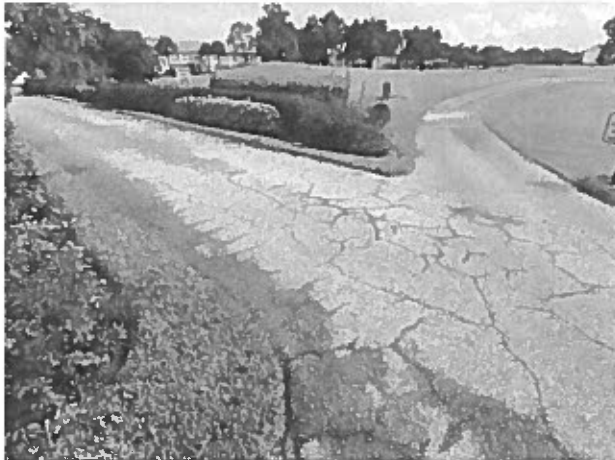
Asphalt pavement – cracks evident

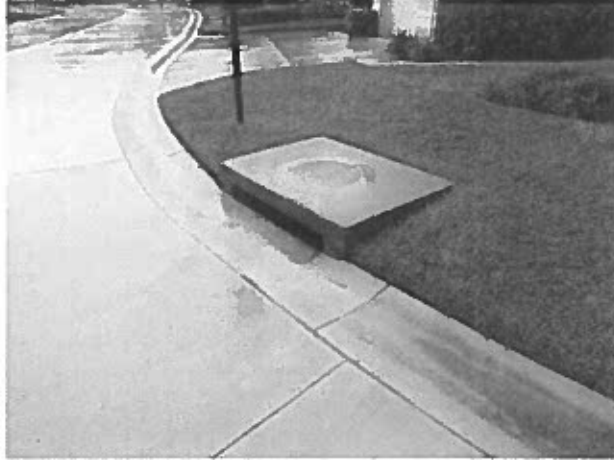
Condition: Good overall

Catch basins - typical

Useful Life: The useful life of catch basins is up to 65 years. However, achieving this useful life usually requires interim capital repairs or partial replacements every 15- to 20-years.

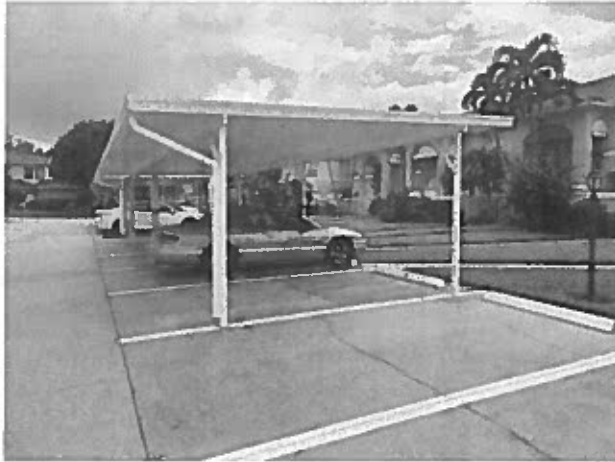
Condition: Good overall with isolated deterioration of the paint finish applications evident

Carport - overview

Useful Life: We depict replacement of the metal roofs to be done every 30 years and we depict paint finish applications and partial repairs to be conducted every 10 years

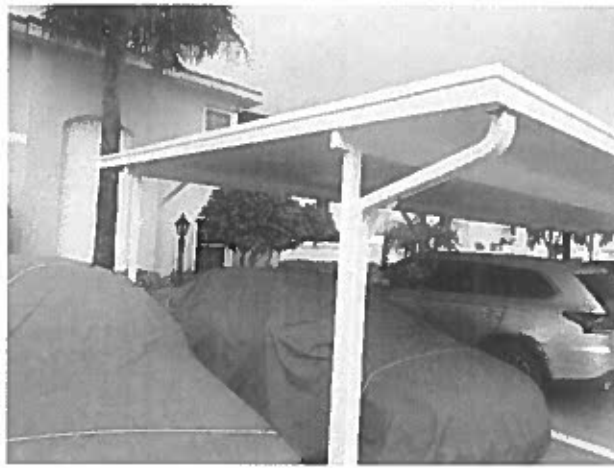
Carports – structural assembly - typical

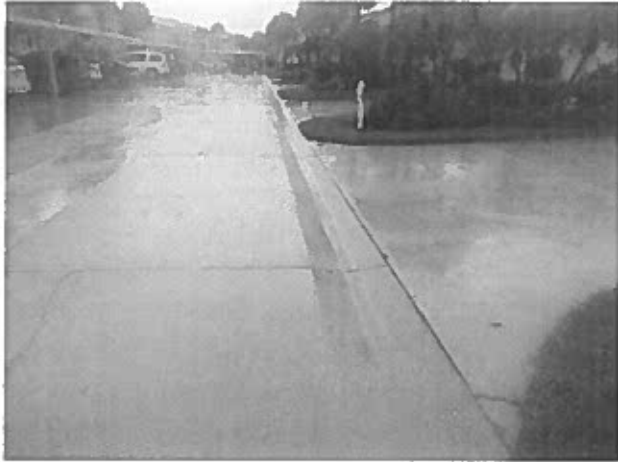
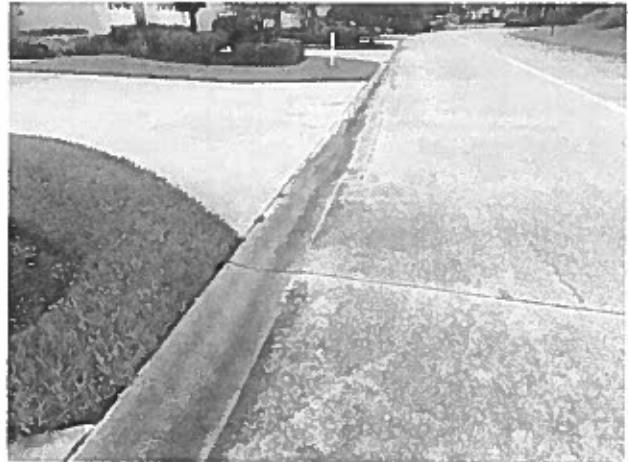
Condition: Good to fair overall with cracking evident

Concrete curbs and gutters - overview

Useful Life: Up to 65 years although interim deterioration of areas is common. We depict replacement of the concrete curbs and gutters to be done in conjunction with the replacement of the concrete street system.

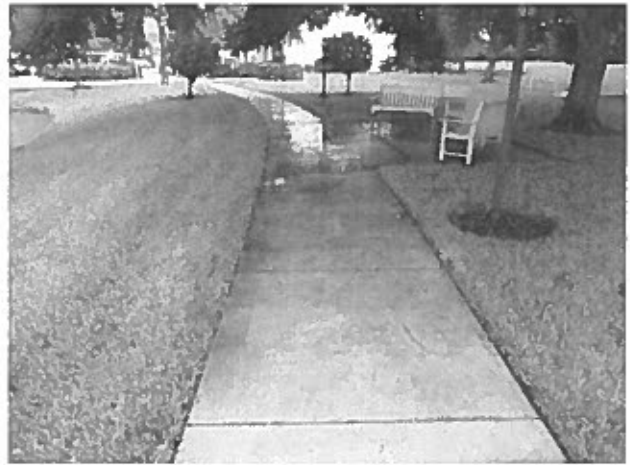
Concrete sidewalks - overview

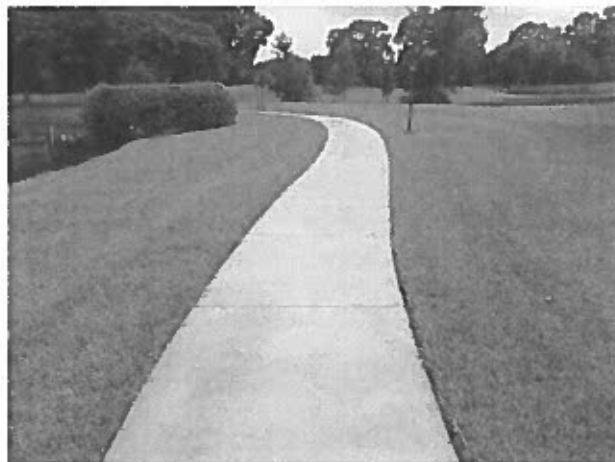
Condition: Good overall with minor uplift evident

Concrete sidewalks - overview

Expenditure Detail Notes: Expenditure timing and costs are depicted in the **Reserve Expenditures** table in Section 3. We estimate that up to 5,425 square feet of concrete sidewalks, or thirty percent (30%) of the total, will require replacement during the next 30 years.

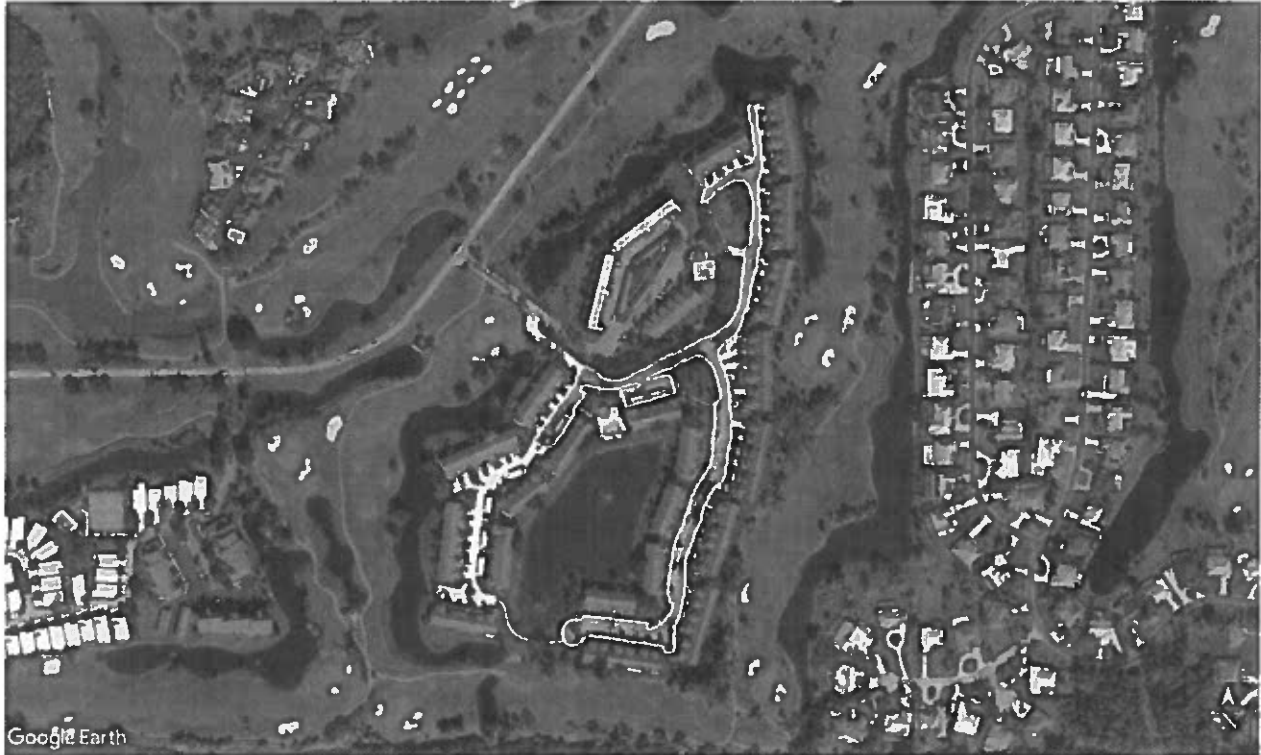
Board informs us that as of the date of our inspection, the community has partially replaced a portion of the concrete street system. The below graphic displays the concrete streets that are still in need of replacement. This is based on our analysis during the inspection as well as conversations with the Board:

Condition: Fair to poor overall. The Board informs us that the base was improperly constructed. During our inspection we noted significant cracks, deterioration of the concrete, and erosion on the underside of the concrete streets throughout the community. Due to these noted conditions, as well as information provided by the Board, we depict replacement of the remaining concrete street system in the near term. This quantity has been estimated to be approximately 120,500 square feet of concrete streets.

Expenditure Detail Notes: Expenditure timing and costs are depicted in the **Reserve Expenditures** table in Section 3. Our estimate of cost for the replacement of the concrete street system includes an allowance for replacement of approximately six inches of base. Our estimate of timing for the replacement is based on information provided by the Board. Additionally, we include an allowance for replacement of up to five percent (5%) or 10,045 square feet of the concrete streets as a subsequent partial replacement event.

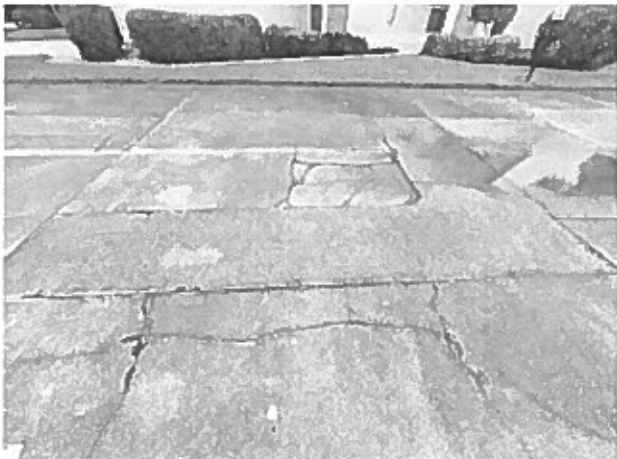
Concrete street system – cracks as well as partial concrete replacement evident

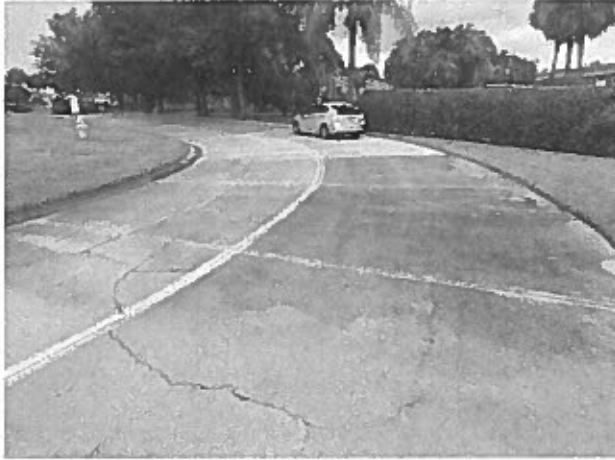
Concrete street system – cracks evident

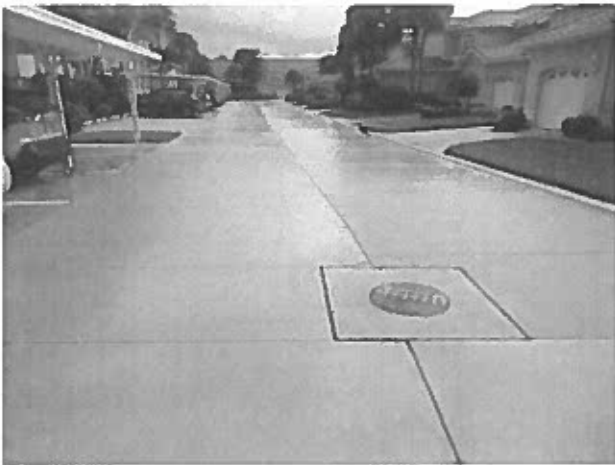
Concrete street system – replaced sections – Coastal Harbour Drive

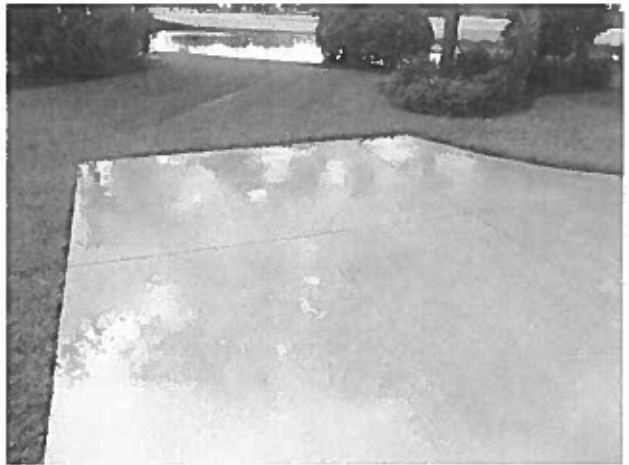
Concrete street system – replaced sections – Coastal Harbour Drive

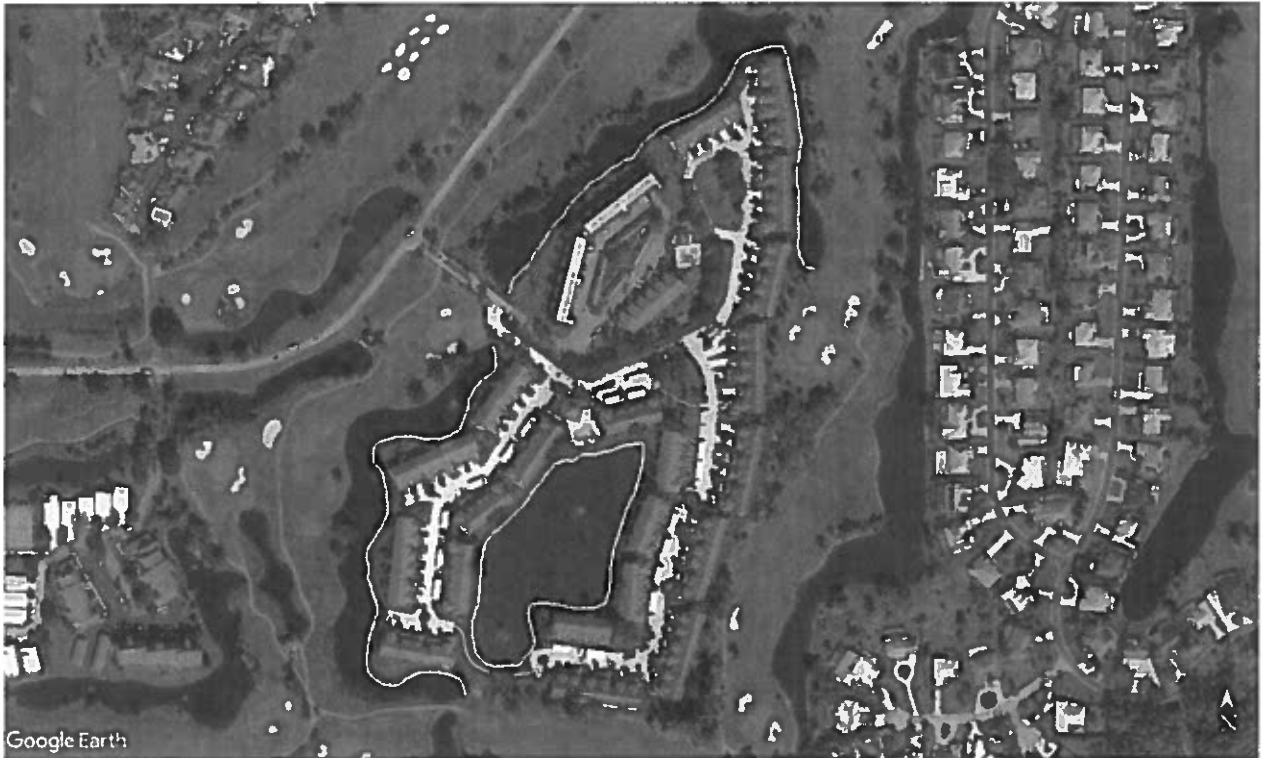
Quantity: The Association is responsible for maintaining approximately 5,180 linear feet of graded pond shorelines. The Board informs us that two of the ponds have a shared responsibility of shoreline maintenance with the adjacent golf course. Our estimate of quantity has taken this into account. See the below graphic for a visual of the ownership of the pond shorelines:

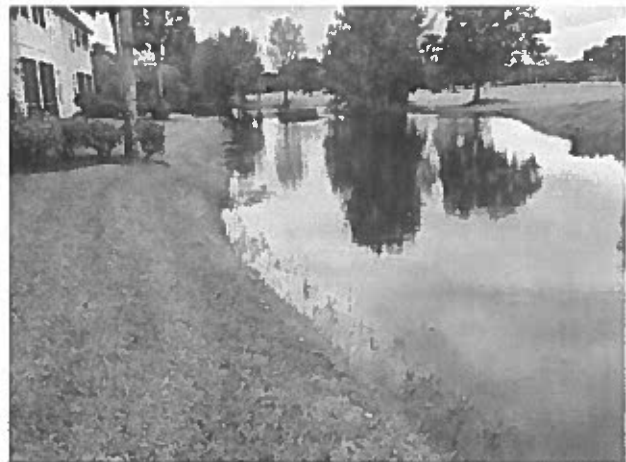
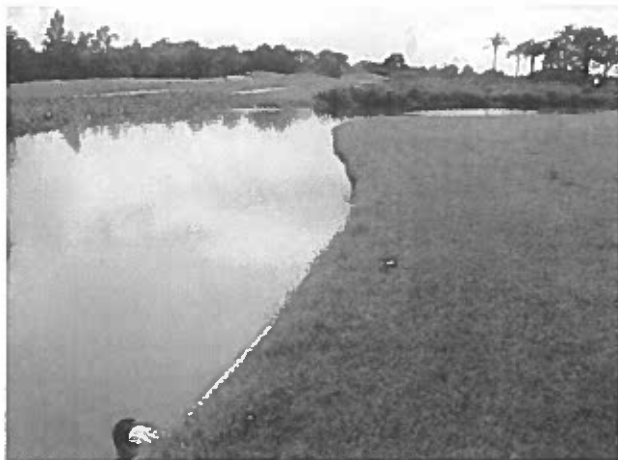
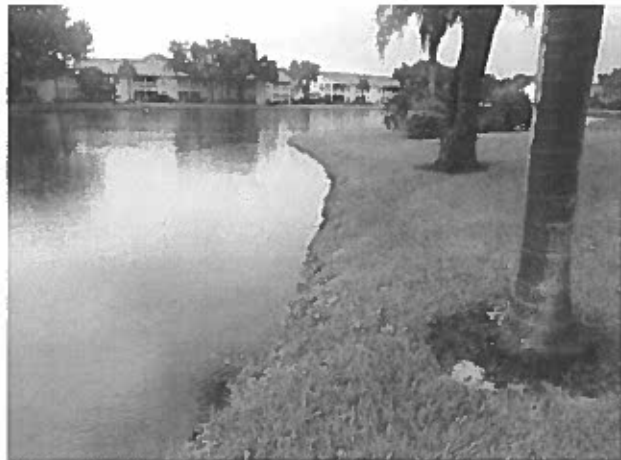
Condition: The Board informs us of a project that is planned to be completed in the near term in order to re-grade the pond shoreline as the shorelines are not currently in compliance with the 4:1 slope rule. The pond shorelines have minor erosion evident.

Pond shorelines – minor shoreline erosion as well as steep slopes evident

Expenditure Detail Notes: Expenditure timing and costs are depicted in the **Reserve Expenditures** table in Section 3. We recommend the Association plan to install a combination of regrading, re-sodding, and plantings around the pond along 775 linear feet, or approximately fifteen percent (15%), of the shoreline per event. Our estimate of cost for the regrading of the pond shorelines in order to bring them into compliance with the 4:1 slope rule was provided by the Board. We depict this project to be completed in a phased manner with regrading of one of the pond shoreline per event in the near term.

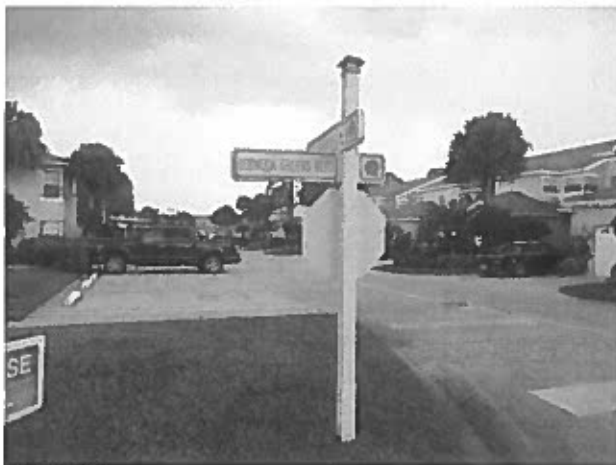
Condition: Good to fair overall with corrosion evident

Street signage - overview

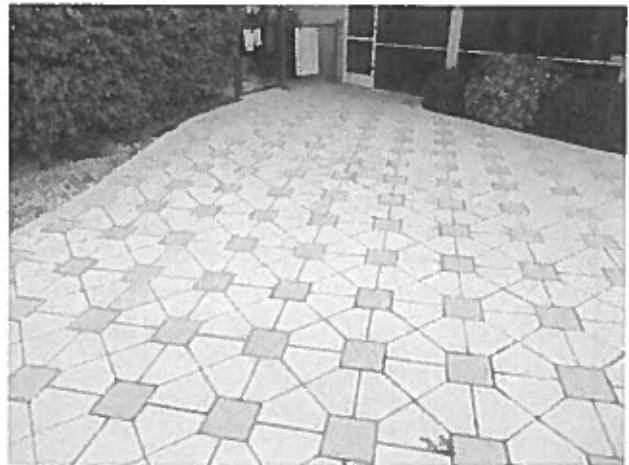
Condition: Fair condition overall. The Board informs us that the deck was improperly constructed due to a lack of proper base material. Due to this, as well as the request of the Board, we have accelerated the replacement of the masonry deck pavers.

Masonry deck pavers - overview

Expenditure Detail Notes: Expenditure timing and costs are depicted in the **Reserve Expenditures** table in Section 3. We recommend the Association fund interim inspections, partial replacements and repairs through the operating budget.

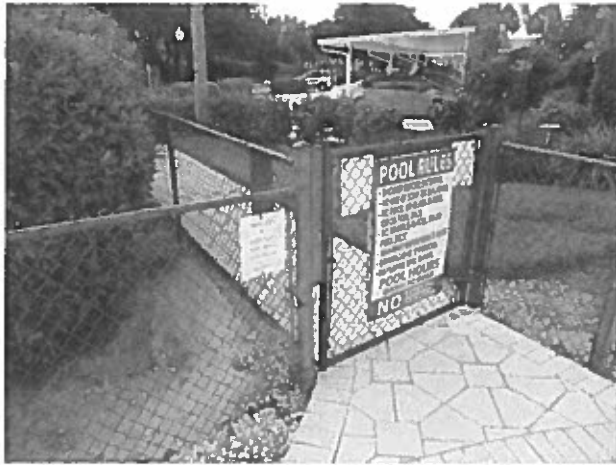
Condition: Good overall condition with deterioration of the finishes evident

Chain link fence - gate
